**Subject:** Solution Leakage & Low Solution Flow

- AquaClean 16XP 56265000, 16ST 56265003, 18ST 56265008, 18FLX 56265001; AX410 56265002; Klenzor 16 56265004, 18MPH 56265005

**Issue:** Solution leaking from under machine. Reduced or loss of solution flow from spray nozzle.

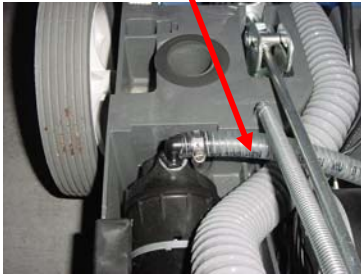
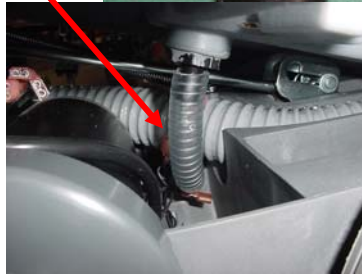
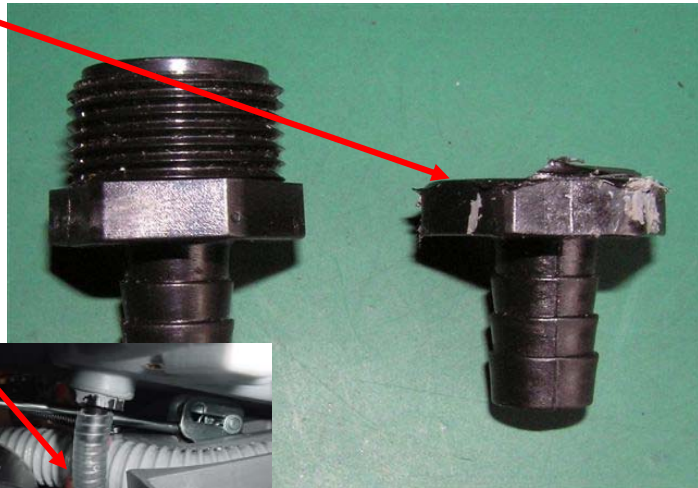
Fig 1-

Fitting 56409507  
fractured at hex

Hose incorrectly routed on  
top of vacuum can stress  
fitting. Hose fitting  
fractured at hex.

Hose correctly  
routed under  
vacuum hose.

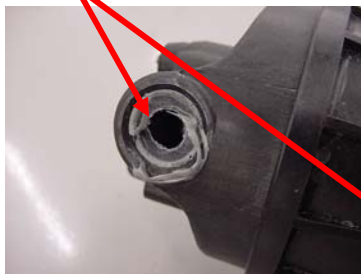
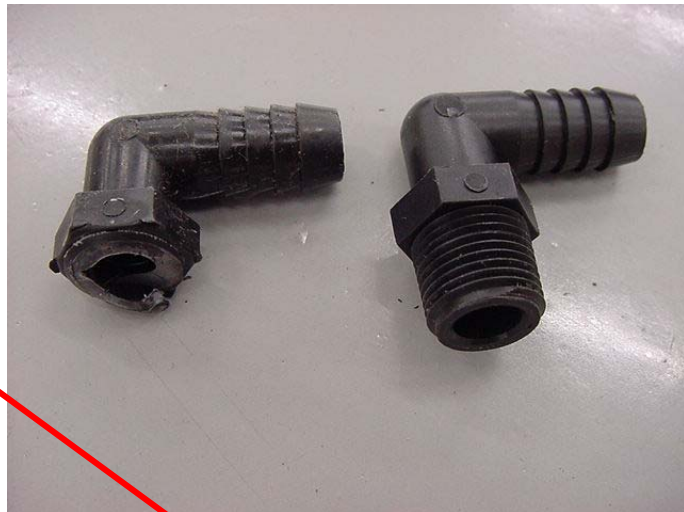
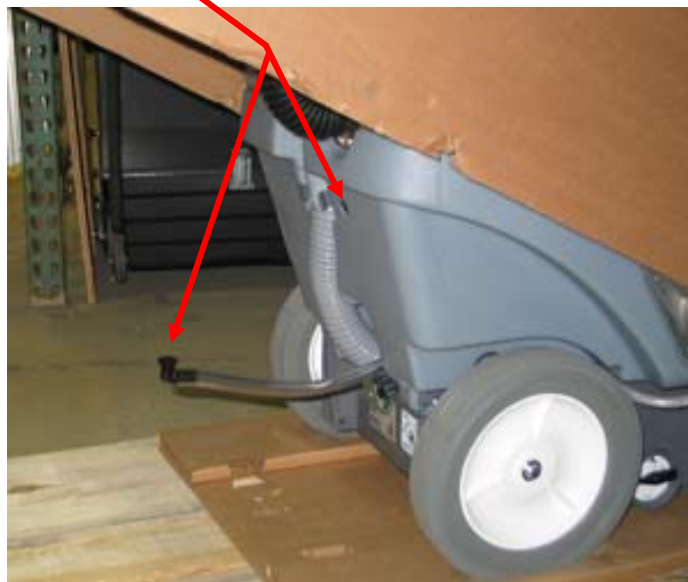
Fig 2-

90 degree elbow 56900069  
fractured at pump inlet & on  
back of solution tank from  
being over torqued.

If fittings are cracked or broken replace or replace pump assembly if fitting can't be removed.

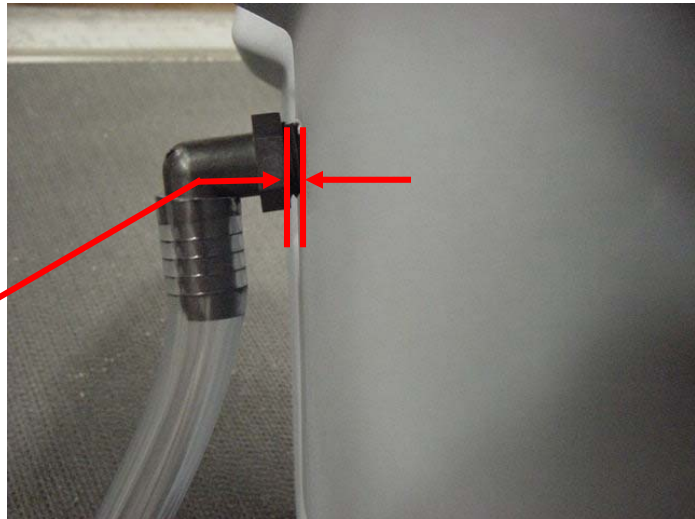
Fig 3-

If fitting has straight threads it can be installed so nut is flush with tank. If fitting has tapered threads it should be installed so there is a 1/8 gap between nut and tank surface. Tightening until nut contacts tank can result in over torquing and cracking or fracturing fitting.

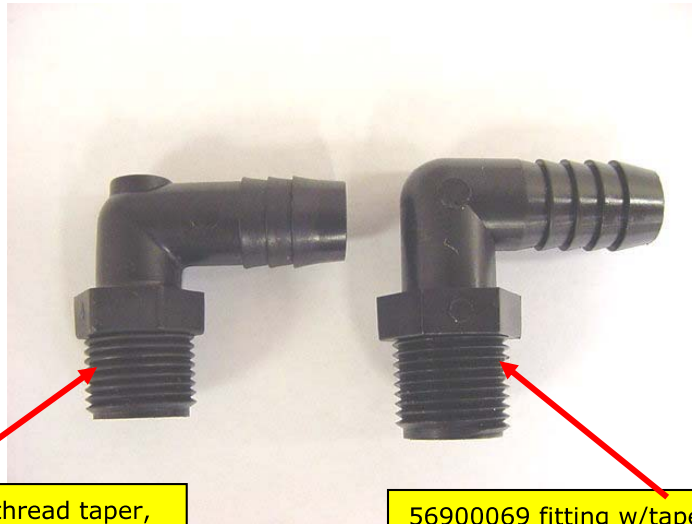
**!CAUTION:** When using aftermarket replacement fittings thread design can vary resulting in over tightening and cracking fitting.

56900069 fitting w/no thread taper,  
0.63" dia.  
Hex 0.68 inches across flats  
3 barbs

56900069 fitting w/tapered  
thread, 0.66-0.68" dia.  
Hex 0.75 inches across flats  
4 barbs

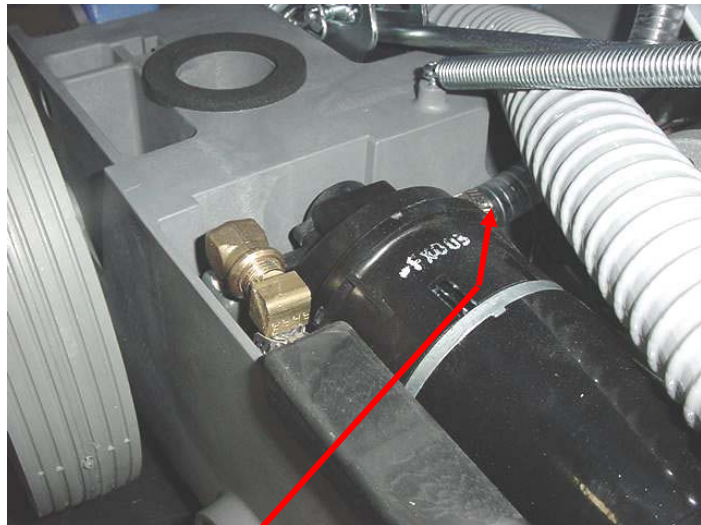
Fig 4- Design change to improve pump priming resulted in pump being re-orientated such that inlet & outlet ports are on the LH & RH side vs top and bottom. Refer to pump bypass kit 56265226 or 56265227.

If solution flow is lost or reduced and pump is running, install pump bypass kit 56265226 or 56265227 to reorient pump. See Fig's 4-7.

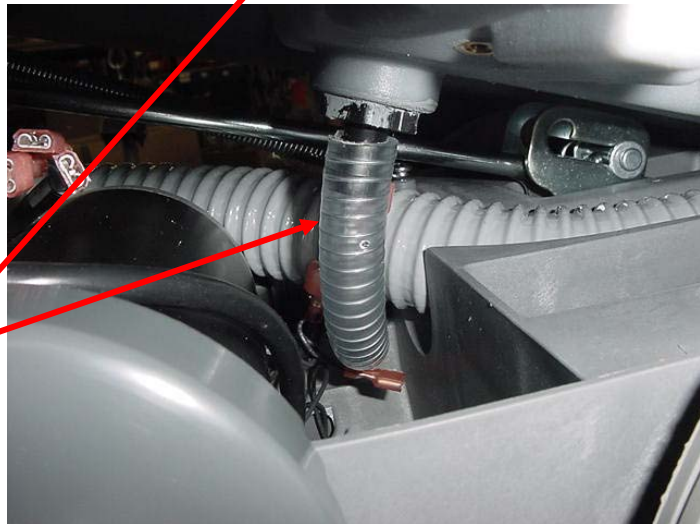
Fig 5-

Straight fitting 56409057 initially used in pump inlet port was replaced with 90 deg elbow shown in Fig 6. Hose routing revised to reduce stress being applied to tank and pump fitting.

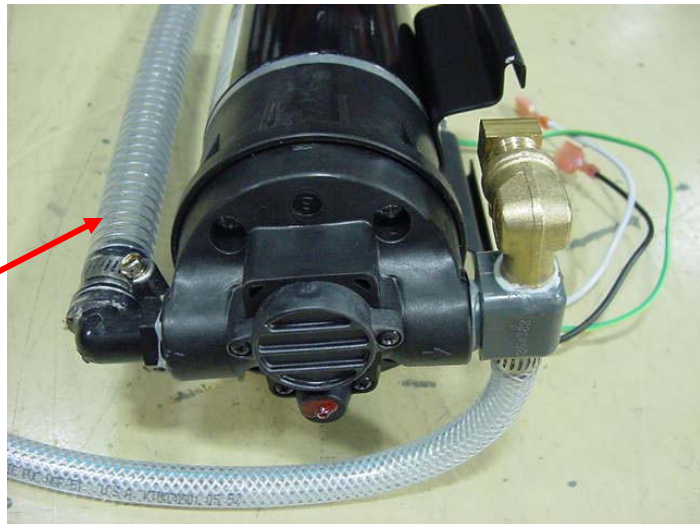
Fig 6-

Straight fitting 56409507 changed to 90 deg elbow 56900069.

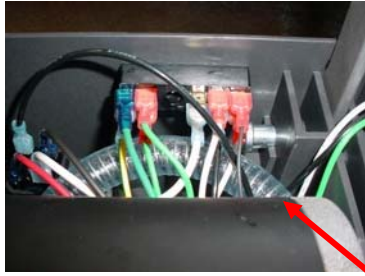
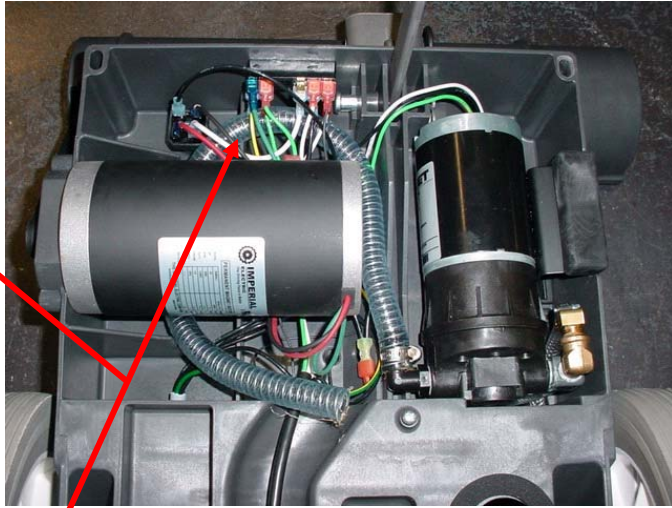
Fig 7- Hose routing between solution tank fitting and pump inlet fitting revised to reduce stress on tank and pump inlet fitting.

Route the solution hose under the terminal block, wires and brush motor as shown.
