Technical Service Bulletin

Subject: Solution Leakage

AquaClean 18FLX, 56265001

Issue: Solution leaking from under machine

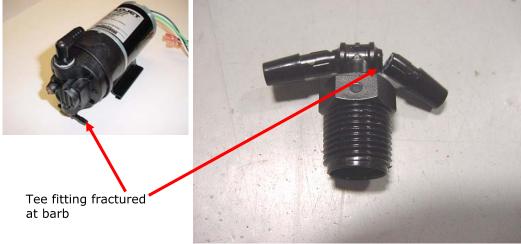
Fig 1-

Cause: Barb on Tee fitting 56507993 can be cracked or fractured if fitting is installed using barbs as

a handle or if spray hose is incorrectly oriented.

On machines with SN's between 2020917 – 2053323 where leakage occurs replace tee fitting with new nylon tee fitting or replace with adapter fitting 56264382, 90 deg brass street elbow 56396632 & 90 deg brass barb fitting 56470138 as shown in Fig's 2-5.

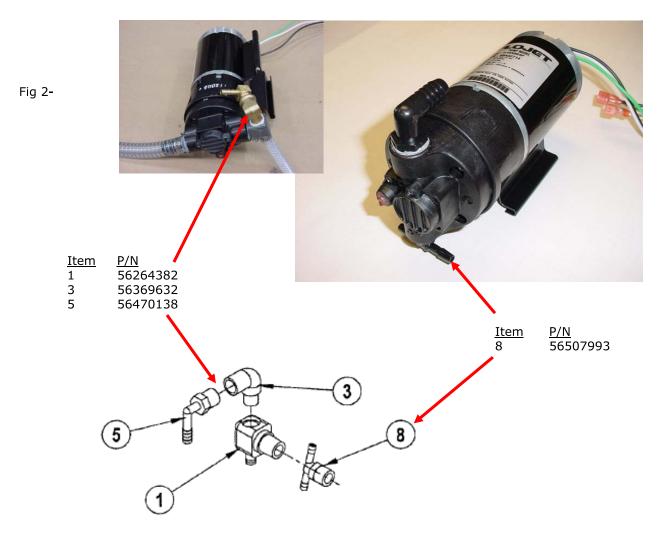
Note: Effective w/SN 2020917 Items 1, 3 & 5 were replaced with item 8 on the 18FLX

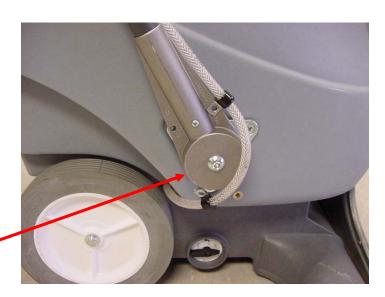
Fig 5-

Spray hose routed out side of machine and fastened to handle.
