## Attention Service Manager/Parts Department

**Subject:** Continuous Product Improvement - Introduction of More Robust Rocker Switch Assembly

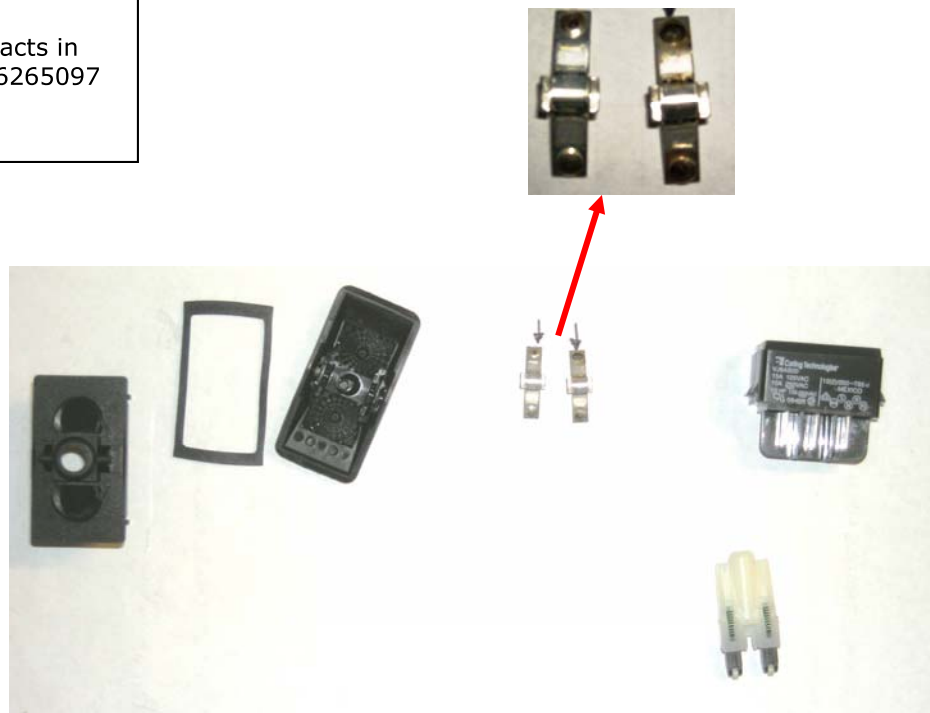
**Issue:** In some applications, premature rocker switch failure is causing the internal switch contacts to degrade quickly (Figure 3).

**Cause:** This premature failure is caused by the high in-rush current characteristics required for initial vacuum motor startup.

**Figure 3:**  
Degraded contacts in  
old switches 56265097  
and 56265107

Effective March 31<sup>st</sup>, 2011 and beginning with serial number 4000015734, the switches that had been used previously were changed to a new and improved switch:

New switch 56381823 replaced switch 56265097

New switch 56381824 replaced switch 56265107
