## Attention Service Manager/Parts Department

**Subject:** Solution Pump Hose Inlet Restriction

**Issue:** Restriction of solution flow to the solution pump due to kinking.

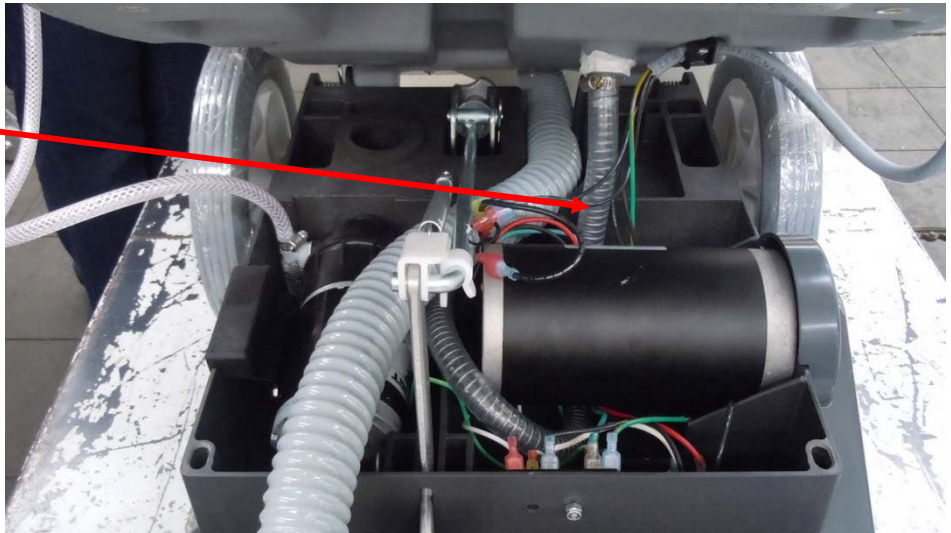
**Fig 1** - Hose PN: 56407267

Locate hose from solution tank to pump as shown in Figure 1

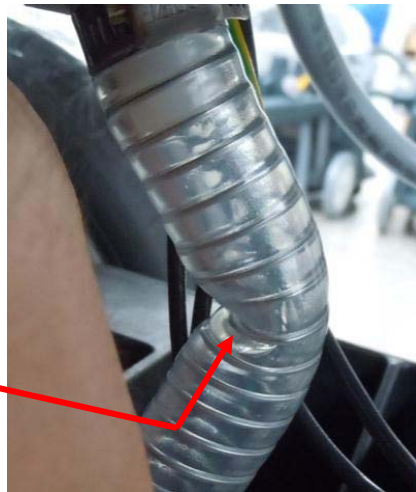
Inspect the solution pump inlet hose for kinking as shown in Figure 2 below.

**Fig 2** - Hose kinked below tank

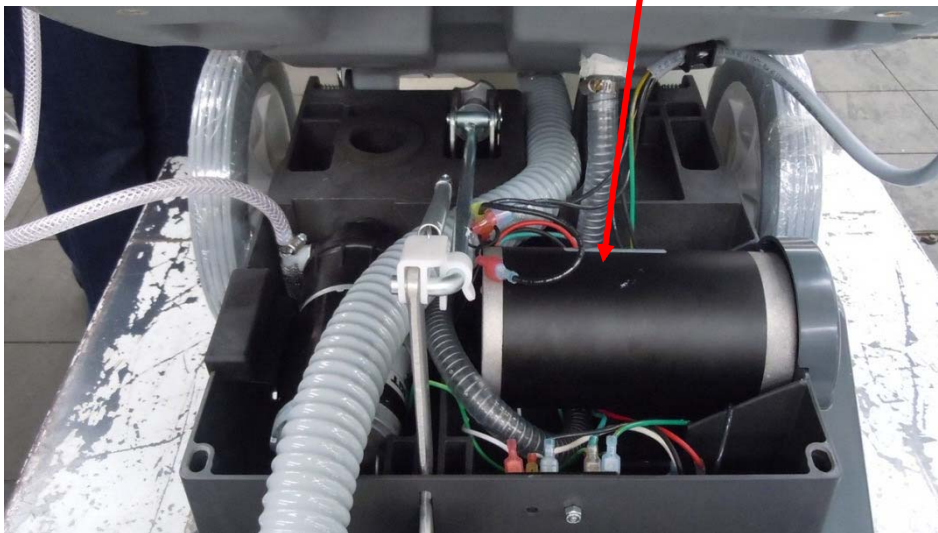
**Fig 3 - Remove brush motor**

If hose is kinked as shown above in Step 2, remove brush motor and inspect hose routing.

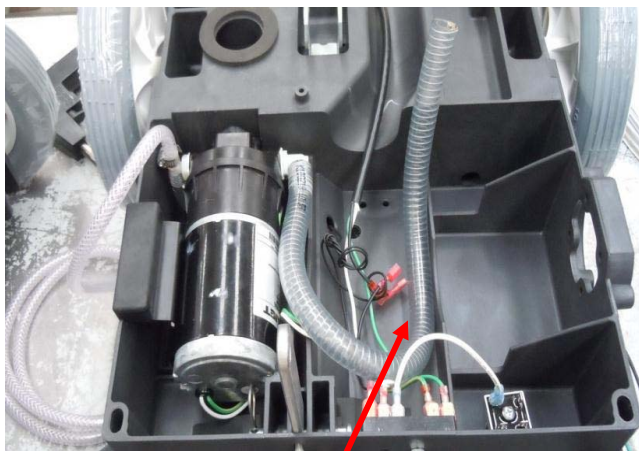
**Cause:** Incorrectly routed solution pump inlet hose creates excessive length of hose between the base and solution tank assemblies.

**Fig 4 - Incorrect Hose Routing**

**Field:** On machines in the serial number range above, inspect the routing of the solution pump inlet hose. If routed as shown in Figure 4, reroute the solution pump inlet hose to the position shown in Figure 5 below.

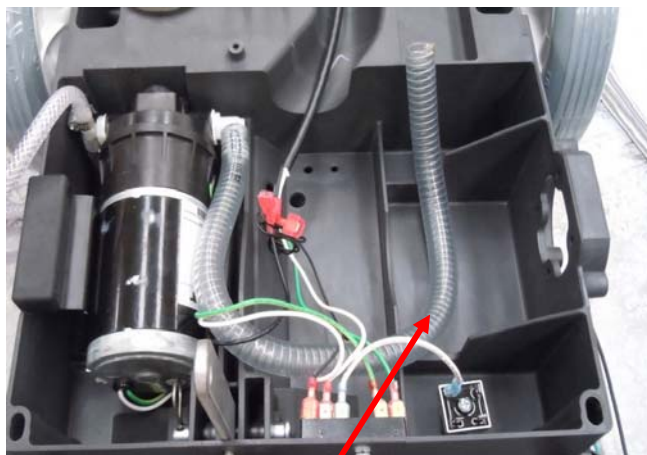
**Fig 5 - Correct Hose Routing**

**Factory:** Effective 5/12/2011 and with SN 4000018212, the solution pump inlet hose has been repositioned to the right of the reinforcement rib under the brush drive motor assembly as shown in Figure 5 below.

If routed improperly, re-route solution pump inlet hose as shown below right (Figure 5).

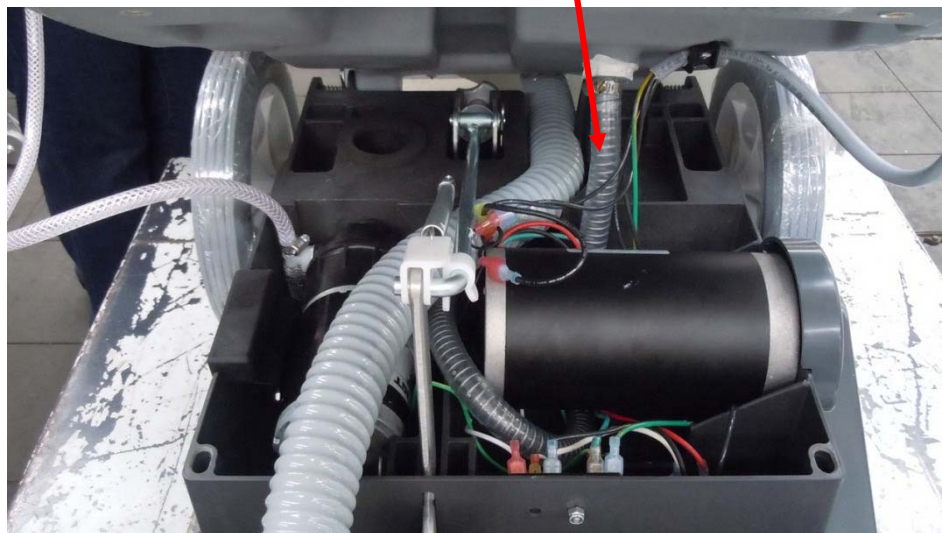
**Fig 6 - Hose position during reassembly**

Reinstall the brush motor and assemble the base to the tank assembly without creating a kink in the solution pump inlet hose.
