# TECHNICAL SERVICE BULLETIN

**Number:** TSB-FC-2017-038

**Symptom:** Machine not starting.

SC250, SCRUBTEC 334C, MA30 13B.

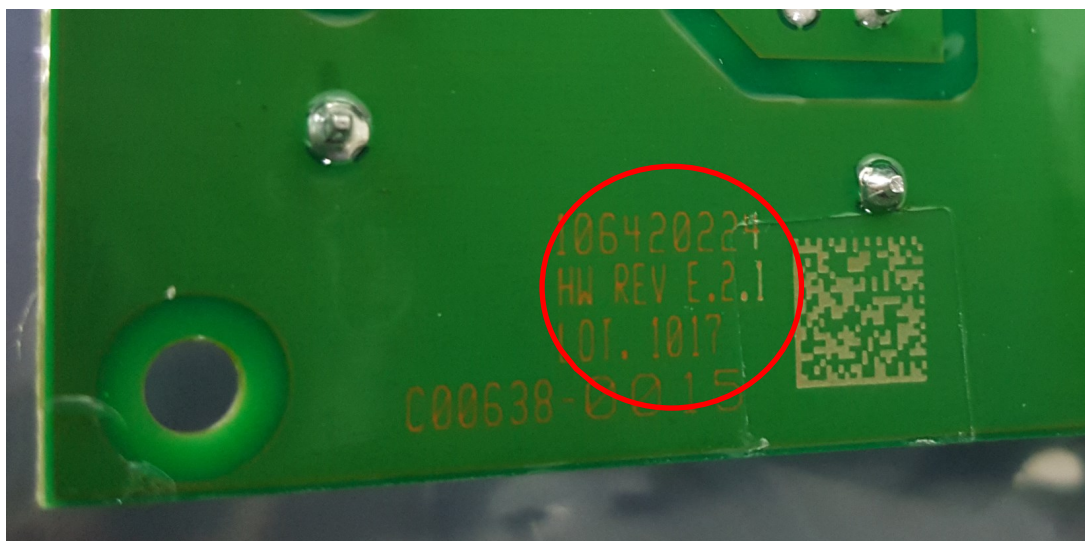
## COMPONENT LOCATIONS / PICTURES:

One of the two pump output MOSFETs on controller (P/N 9100001960) was found short-circuited.

Revision change from "E.1.1" to "E.2.1"

Replace the PCB if a failure occurs (fix as fails)

9100002260 - CONTROLLER MAIN MACH.P24 PROGR. SIP
