# TECHNICAL SERVICE BULLETIN

# Nilfisk

**Number:** TSB-FC-2017-062

**Symptom:** Battery deactivated, 3 red flashes.

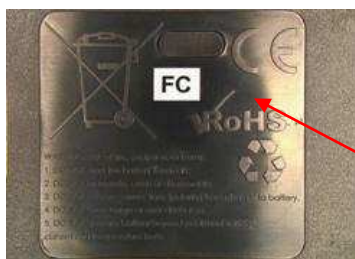
Identification label added on the machine box

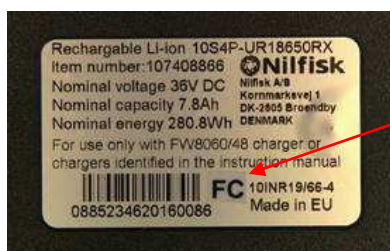
Reworked battery—add-on label

New production battery—print directly on the existing label.
