# Technical Service Bulletin

**MODEL(S) AFFECTED: T600/T600e/T600EE Walk-Behind Scrubbers**

**SUBJECT:** **i-Drive Fold-Back UPDATE** - Ref. TSB No. 241 released January 11, 2019. Machine begins to propel very slowly and will not climb an inclined surface during normal operating conditions. This is caused when the i-Drive current load exceeds the set limit which automatically reduces the current flow to protect transaxle motor from overheating, also known as a "fold-back". The machine will not display a fault code when in fold-back mode.

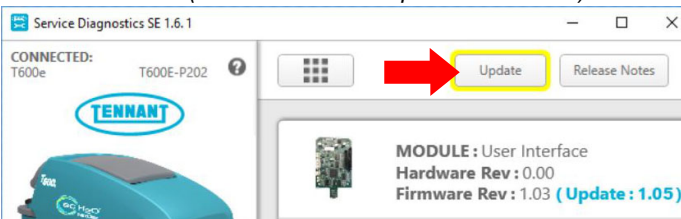
1. Using the latest Service Diagnostics software version, update the UI Firmware. (T600e model example shown below)

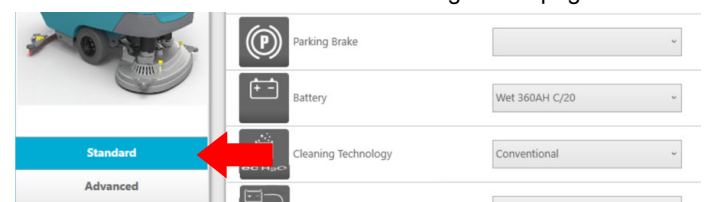
4. Select "Standard" to return to the Configuration page.

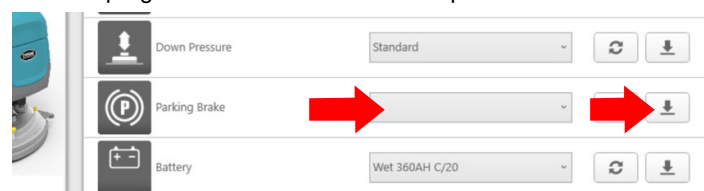
6. Apply the selection by pressing the down arrow. The iDrive will be reprogrammed with new fold-back parameters.
