# Technical Service Bulletin

**MODEL(S) AFFECTED:** **T600/T600e/T600EE Walk-Behind Scrubbers equipped with membrane control panels**

**SUBJECT:** **Battery Discharge Indicator (BDI)** fails to display the LED rippling mode during the charge cycle. A recent User Interface (UI) firmware release has contributed to this behavior glitch.

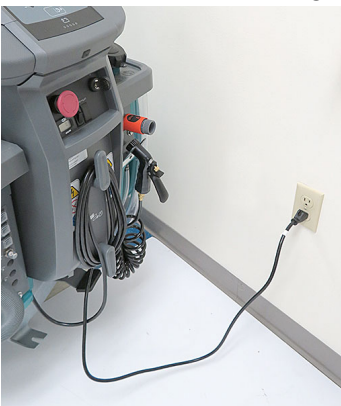
BDI fails to ripple during charge cycle.

**PURPOSE:** To restore the BDI charge cycle behavior install the following User Interface (UI) firmware revisions as instructed below.

- T600 - UI Firmware Rev: 1.03 or later
- T600 Pro-panel - UI Firmware Rev: 1.04 or later
- T600EE - UI Firmware Rev: 1.03 or later
- T600e - UI Firmware Rev: 1.04 or later
- T600e equipped w/ IRIS - UI Firmware Rev: 1.9 or later
