# Technical Service Bulletin

**MODEL(S) AFFECTED:** B5 propel, B7, T300/e propel, T500/e, T600/e, SpeedGleam 5 propel, SpeedGleam 7, Speed Scrub 300 propel and Speed Scrub 500  
N. America models manufactured before April 12, 2021.

**SUBJECT:** Speed Control potentiometer failure. Over time, under normal operating use, the potentiometer may exhibit a brief open-circuit condition and cause a propel fault. The detected fault will automatically put the i-Drive in the slow, safe mode or even cause complete propel failure. A simple key-cycle may clear the fault temporally, however the fault can reoccur when adjusting speed dial.

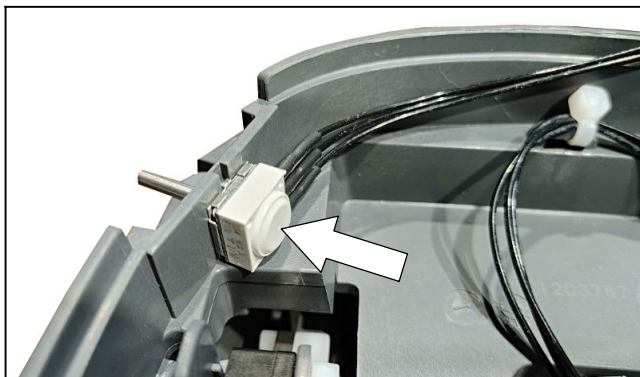
## New Replacement Potentiometer p/n 1256757

The new potentiometer is a direct replacement and does not require any specific installation instructions. To identify the difference between the previous potentiometers, the body on the new potentiometer is thinner.

**PURPOSE:** To repair potentiometer, order replacement potentiometer (p/n 1256757). The new potentiometer is designed with a ceramic-based resistance element for long term durability. It's also designed without speed setting detents, therefore the speed control dial will feel different to the operator.

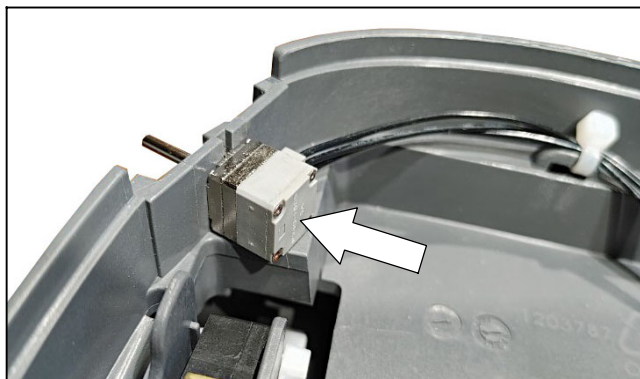
p/n 1246392

## Previous Potentiometers (Discontinued)

**NOTES:** **Warranty Information:** Standard warranty terms apply. If you have any existing inventory of the previous potentiometers, it is advised to scrap them out and reorder the new replacement part.
