| <b>Machine</b> | <b>TASKI swingo 1650, 1660, 1850, XP, 2100</b> |
| <b>Subassembly</b> | <b>Electronic</b> |

## Diode and marking of positive terminal

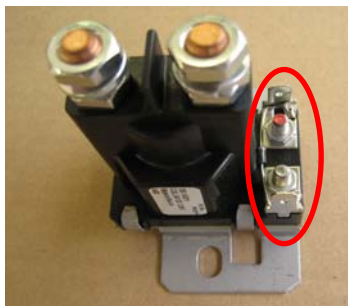
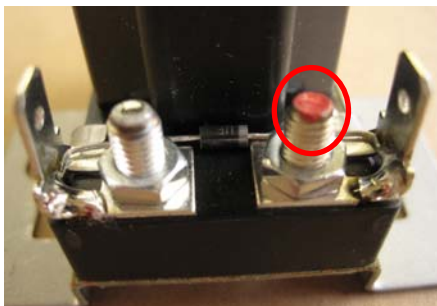
Analysed defective electronic boards and relay showed signs as if induction current has damaged some of the electronic components and is limiting the lifetime of the relay.

Relay with diode and red marked positive terminal

In order to improve protection of electronic board and relay against this kind of outage a diode has been installed parallel to the coil of the relay.

For an improved protection of the electronic and increase lifetime of the relay, it is important to connect the relay properly. For this reason the positive terminal has been marked red.
