TECHNICAL SERVICE BULLETIN

NSS® Enterprises, Inc.

Affected Products: All machines with Dual Pro Chargers

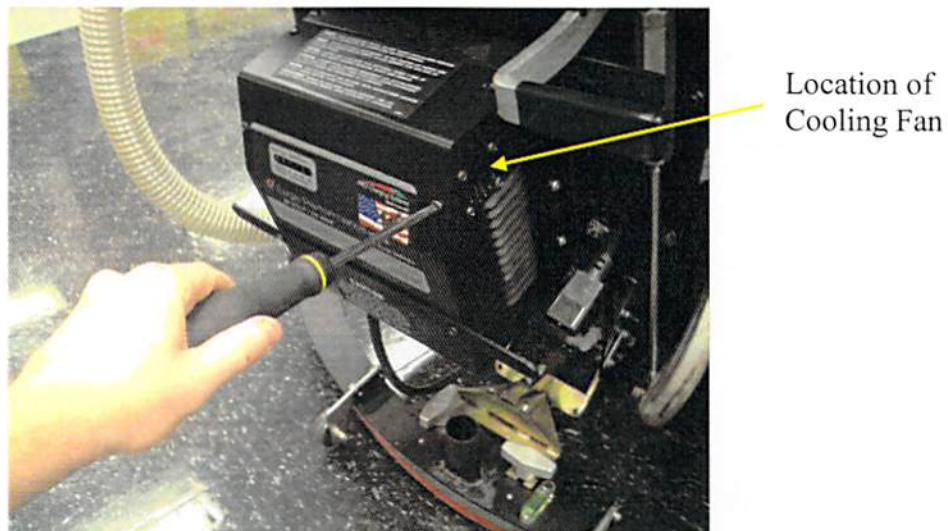
Dual Pro Charger

Problem Description: Customers have noticed the Dual Pro chargers have a chance of overheating.

Root Cause: The cooling fan inside the Dual Pro charger fails.

Corrective Action: Create a kit to retrofit Dual Pro charging units with a new cooling fan.

Field Installation: Customers that need a new cooling fan, order kit number 2698441 (KIT, DP CHRGER, FAN REFURB.) and follow the instructions that are included.

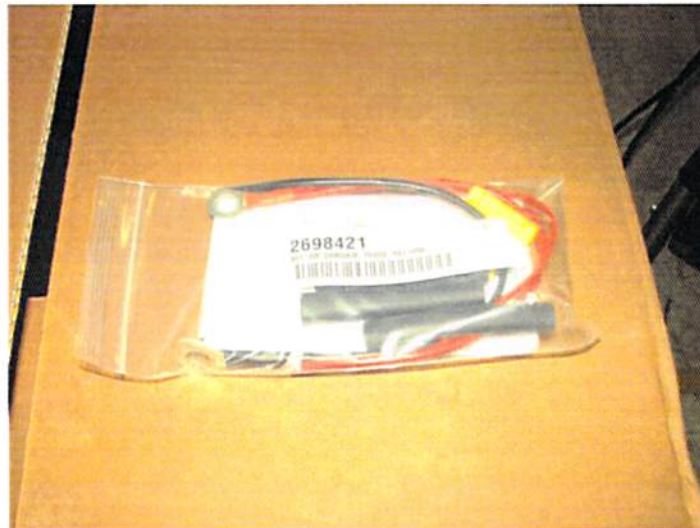
Ring Terminal Refurbishment Kit

Problem Description: The leads on the Dual Pro chargers can become corroded and inhibit the batteries ability to charge properly.

Root Cause: Due to the caustic environment of the battery compartment corrosion can form on the ring terminals and after time create a bad connection between the ring terminals and the wires.

Corrective Action: Create a kit to retrofit Dual Pro charging units with new ring terminals.

Field Installation: Customers that need new ring terminals, order kit number 2698421 (KIT, DP CHRGR, TERM. REFURB.) and following the instructions that are included.
