| <b>Machines</b> | <b>TASKI ergodisc omni, 1200</b> |
| <b>Subassembly</b> | <b>Chassis</b> |

## Introduction electronic relay

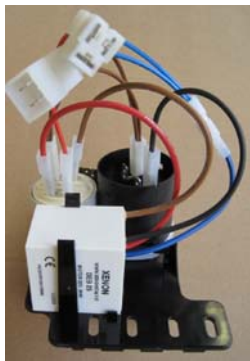
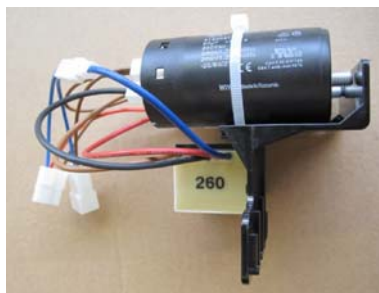
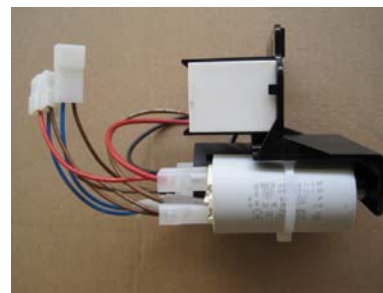
We repeatedly received input from the field that the capacitors breakdown. Investigations have shown that common reasons for these failures are voltage fluctuations (e.g. unstable power supply, extension cables, etc.) combined with short switch-on time of the machine. These two factors have a vital impact on the live expectation of the capacitors (mainly the start capacitor). The new electronic relay optimises the switching process between start- and operating capacitor, which will help to reduce the breakdowns.

Internal tests have shown that in case of a malfunction/breakdown of the relay, the other two components (capacitors) of the relay plate can also get damaged. In case of a service we recommend to exchange the complete electric panel. The electronic relay will not be introduced as spare part.
