# GTS Newsletter

2009/05E

| <b>Machine</b> | <b>TASKI swingo XP</b> |

## Ball Joint / Flat Spring of Squeegee Lowering Mechanism

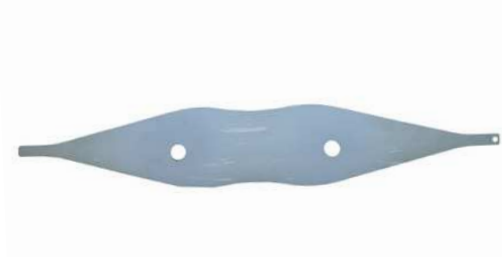
Deepness of ball joint bracket increased to app. 10mm

Bolts will be used as distance pieces

To the flat spring 2 holes have been added (holes are not centered)

To avoid such damages the ball joint has been modified and the tolerance of the flat spring has been reduced. With these adjustments it is no longer possible that the swinging arm can pop out of the bracket.

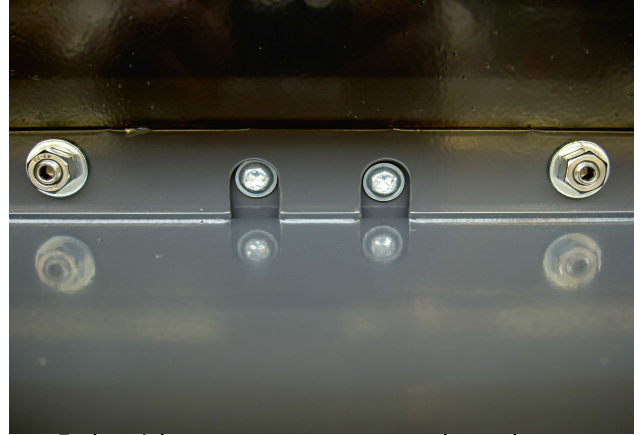
Spring compartment

Bolt with counternut at step board

- Remove the 2 centred screws of the step board fixation
- Get access to the flat spring compartment
- Remove current/old flat spring
- Position new flat spring with holes (Attention: holes are not centred)
- Mount the 2 limitation bolts
- Refasten new flat spring
- Mount counternut and washer onto the bolts to fixate the step board
