**Technical Service Bulletin**

Subject: Solution Leakage

• AquaClean 18FLX, 56265001

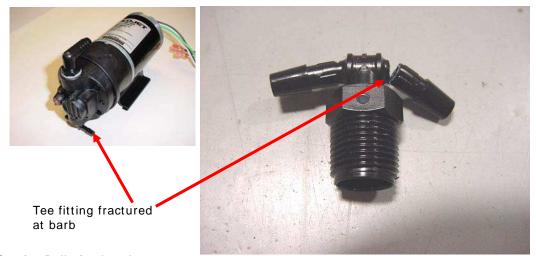
Fig 1-

**Issue:** Solution leaking from under machine

**Cause:** Barb on Tee fitting 56507993 can be cracked or fractured if fitting is installed using barbs as a handle or if spray hose is incorrectly oriented.

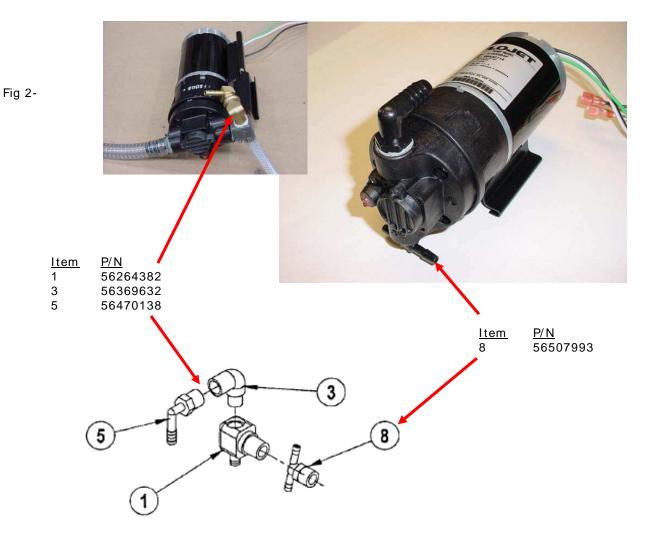
Note: Effective w/SN 2020917 Items 1, 3 & 5 were replaced with item 8 on the 18FLX

On machines with SN's between 2020917 – 2053323 where leakage occurs replace tee fitting with new nylon tee fitting or replace with adapter fitting 56264382, 90 deg brass street elbow 56396632 & 90 deg brass barb fitting 56470138 as shown in Fig's 2-5.

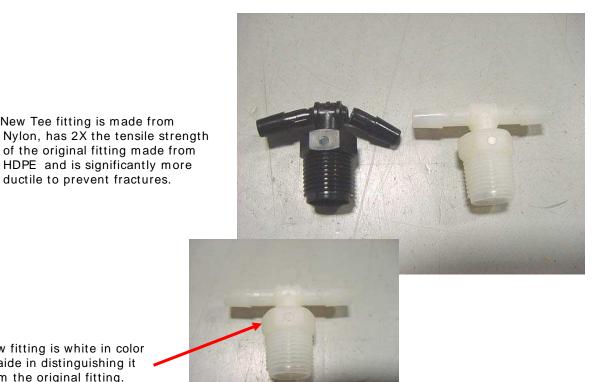
New fitting is white in color to aide in distinguishing it from the original fitting.

Fig 3- New Tee fitting is made from

ductile to prevent fractures.

Effective 4/29/08 with SN's noted below the tee fitting material was revised from polyethylene to nylon to increase strength and prevent breakage.

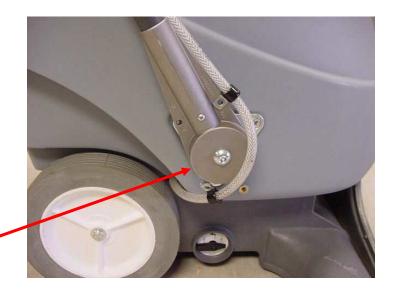
Fig 5-

Spray hose orientation if plastic T fitting used.

Spray hose routed out side of machine and fastened to handle.
