## Attention Service Manager/Parts Department

**Subject:** Solution Pump Hose Inlet Restriction

**Models Affected:**

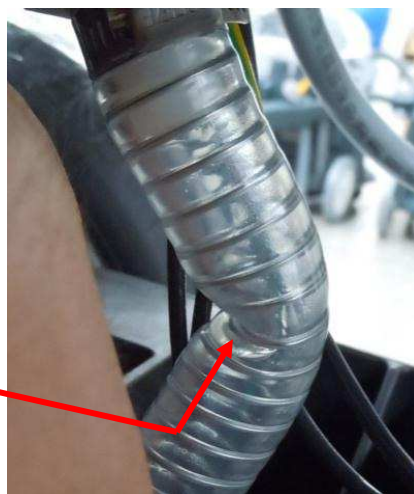
**Issue:** Restriction of solution flow to the solution pump due to kinking.

**Fig 2** - Hose kinked below tank

Inspect the solution pump inlet hose for kinking as shown in Figure 2 below.

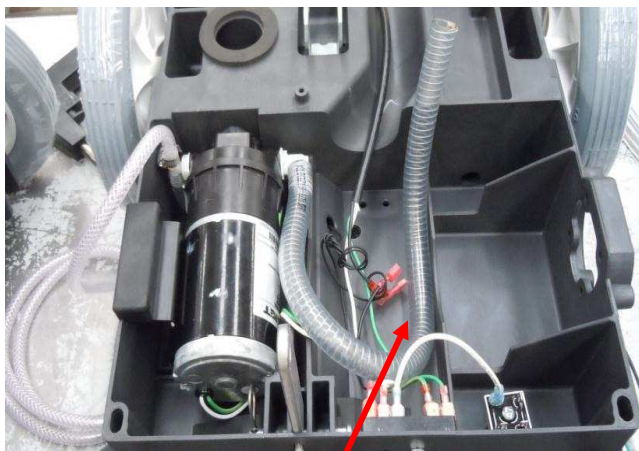
**Cause:** Incorrectly routed solution pump inlet hose creates excessive length of hose between the base and solution tank assemblies.

**Fig 4 - Incorrect Hose Routing**

**Field:** On machines in the serial number range above, inspect the routing of the solution pump inlet hose. If routed as shown in Figure 4, reroute the solution pump inlet hose to the position shown in Figure 5 below.

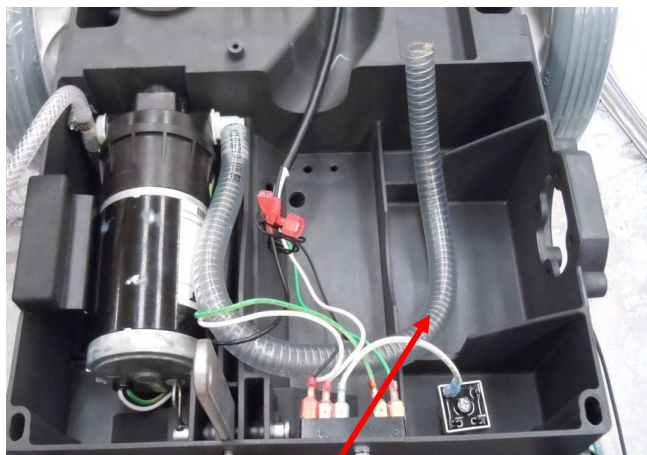
**Fig 5 - Correct Hose Routing**

**Factory:** Effective 5/12/2011 and with SN 4000018212, the solution pump inlet hose has been repositioned to the right of the reinforcement rib under the brush drive motor assembly as shown in Figure 5 below.

If routed improperly, re-route solution pump inlet hose as shown below right (Figure 5).

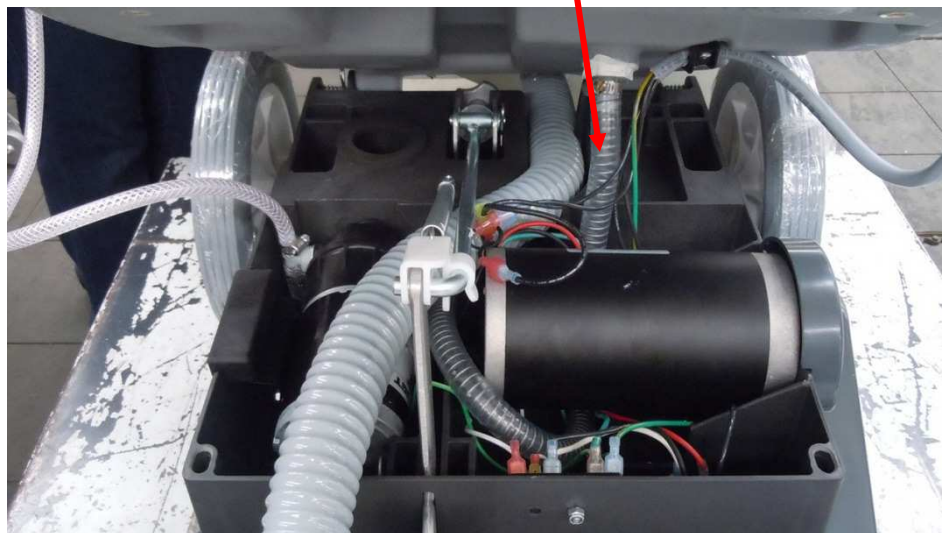
**Fig 6** - Hose position during reassembly

Reinstall the brush motor and assemble the base to the tank assembly without creating a kink in the solution pump inlet hose.
