**Subject:** Solution Leakage & Low Solution Flow

**Models Affected:**

- AquaClean 16XP 56265000, 16ST 56265003, 18ST 56265008, 18FLX 56265001; AX410 56265002; Klenzor 16 56265004, 18MPH 56265005

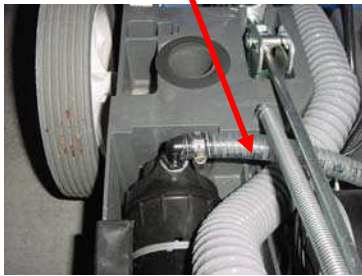
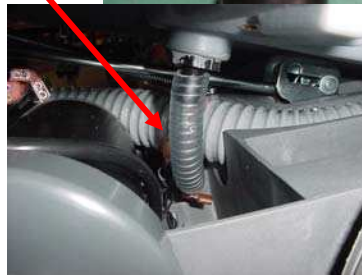
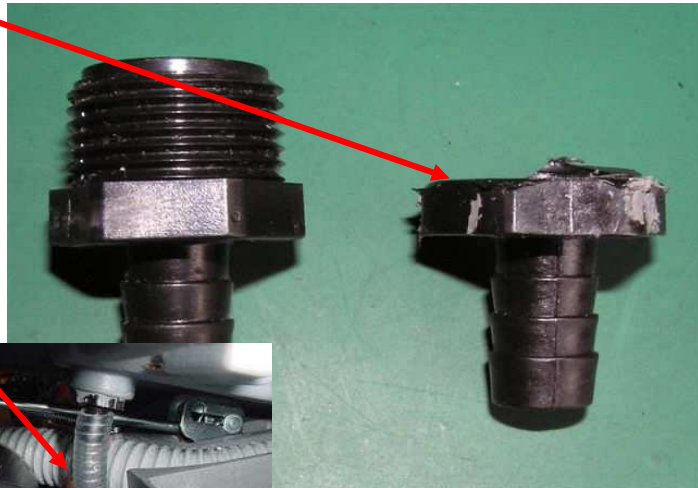
Fig 1-

Fitting 56409507  
fractured at hex

Hose incorrectly routed on  
top of vacuum can stress  
fitting. Hose fitting  
fractured at hex.

Hose correctly  
routed under  
vacuum hose.

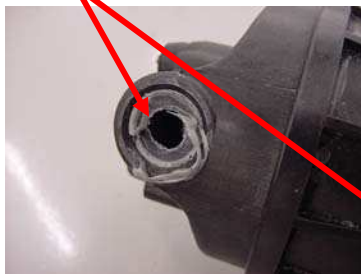
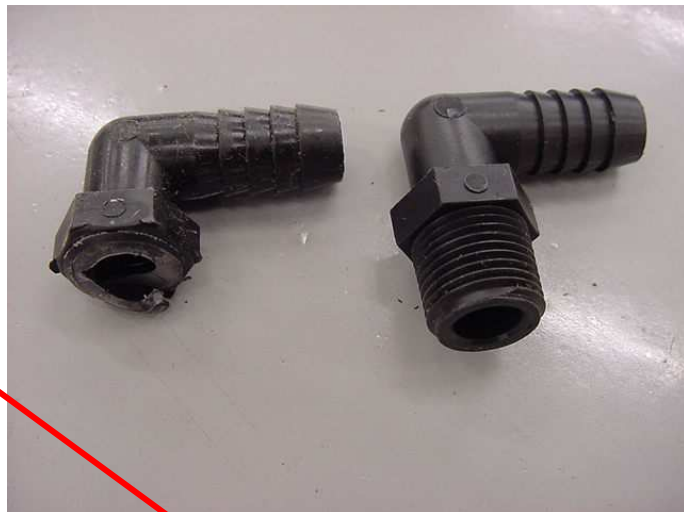
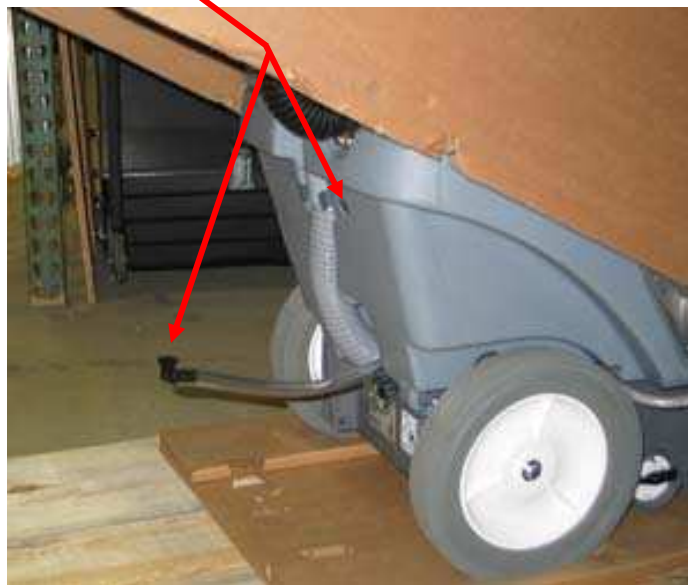
Fig 2-

90 degree elbow 56900069  
fractured at pump inlet & on  
back of solution tank from  
being over torqued.

If fittings are cracked or broken replace or replace pump assembly if fitting can't be removed.

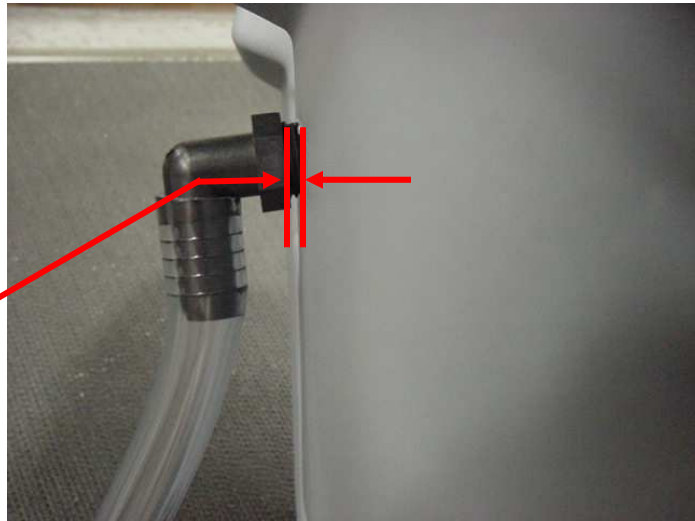
Fig 3-

If fitting has straight threads it can be installed so nut is flush with tank. If fitting has tapered threads it should be installed so there is a 1/8 gap between nut and tank surface. Tightening until nut contacts tank can result in over torquing and cracking or fracturing fitting.

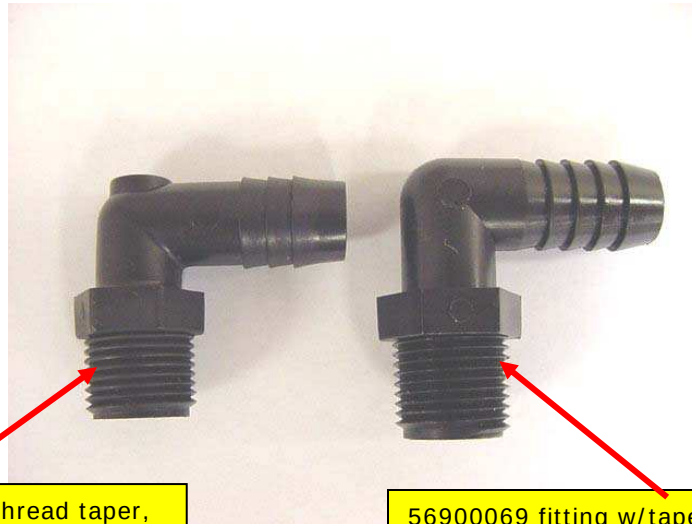
**!CAUTION:** When using aftermarket replacement fittings thread design can vary resulting in over tightening and cracking fitting.

56900069 fitting w/no thread taper,  
0.63" dia.  
Hex 0.68 inches across flats  
3 barbs

56900069 fitting w/tapered  
thread, 0.66-0.68" dia.  
Hex 0.75 inches across flats  
4 barbs

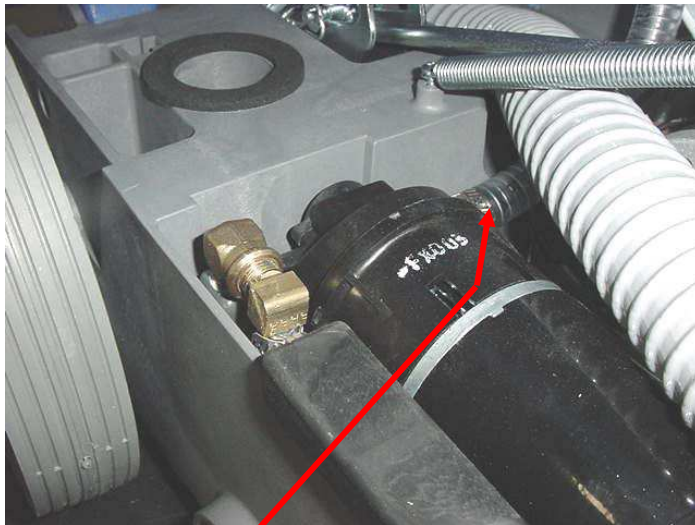
Fig 4- Design change to improve pump priming resulted in pump being re-orientated such that inlet & outlet ports are on the LH & RH side vs top and bottom. Refer to pump bypass kit 56265226 or 56265227.

If solution flow is lost or reduced and pump is running, install pump bypass kit 56265226 or 56265227 to reorient pump. See Fig's 4-7.

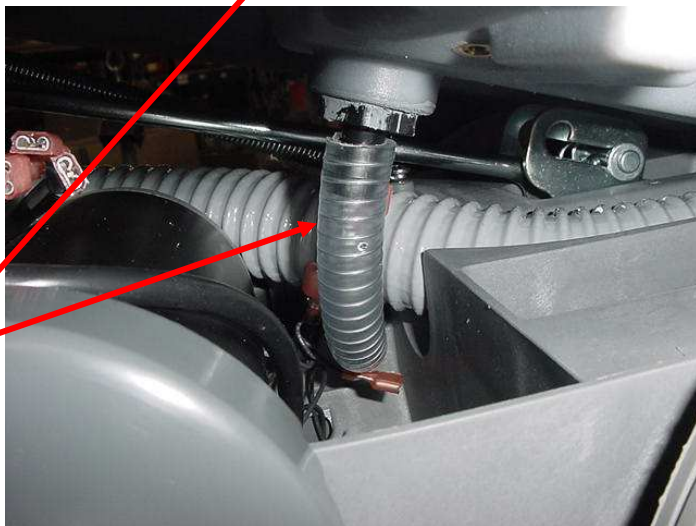
Fig 5-

Straight fitting 56409057 initially used in pump inlet port was replaced with 90 deg elbow shown in Fig 6. Hose routing revised to reduce stress being applied to tank and pump fitting.

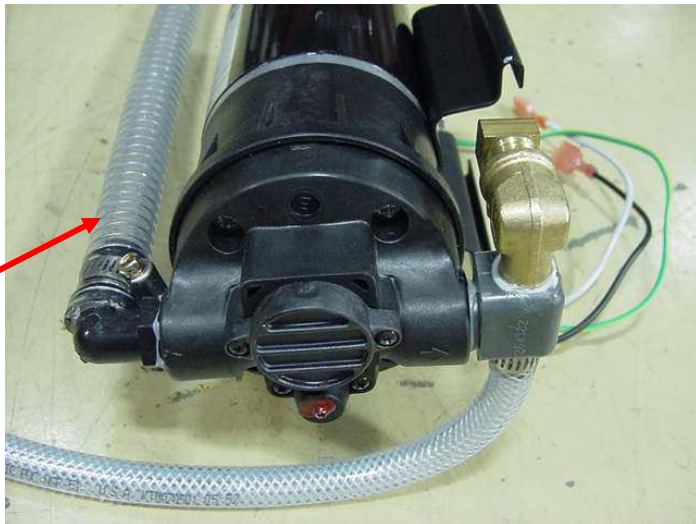
Fig 6-

Straight fitting 56409507 changed to 90 deg elbow 56900069.

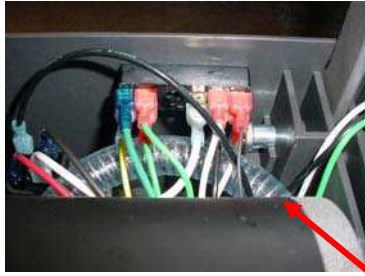
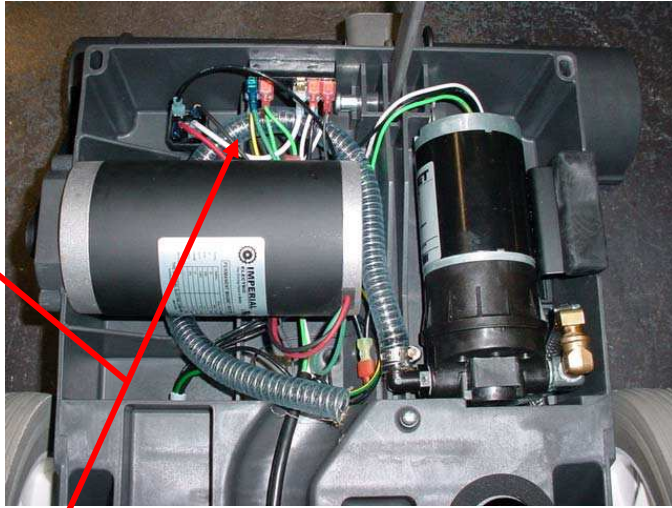
Fig 7- Hose routing between solution tank fitting and pump inlet fitting revised to reduce stress on tank and pump inlet fitting.

Route the solution hose under the terminal block, wires and brush motor as shown.
