Brush belt breaking and/or rubbing on housing

Advance: Aquaclean 16ST, 16XP, 18FLX, 18ST

Clarke: Clean Track S16, L18, 18 Wash & Rinse

Nilfisk Grey: AX 410

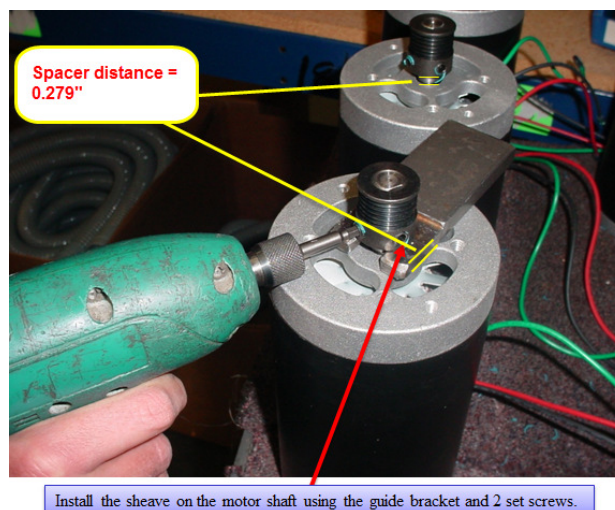
The motor sheave and brush drive sheave are not aligned.

The sheave on the brush motor shaft must be aligned with the brush drive sheave.

When installing the sheave on the brush motor set the gap to 0.279" (7mm) as shown below.
