## Attention Service Manager/ Parts Department

**Subject:** Vac Shoe Bracket Pin Weld Fracture

- Adphibian (all models)
- AquaPLUS (all models)
- AX651 (all models)

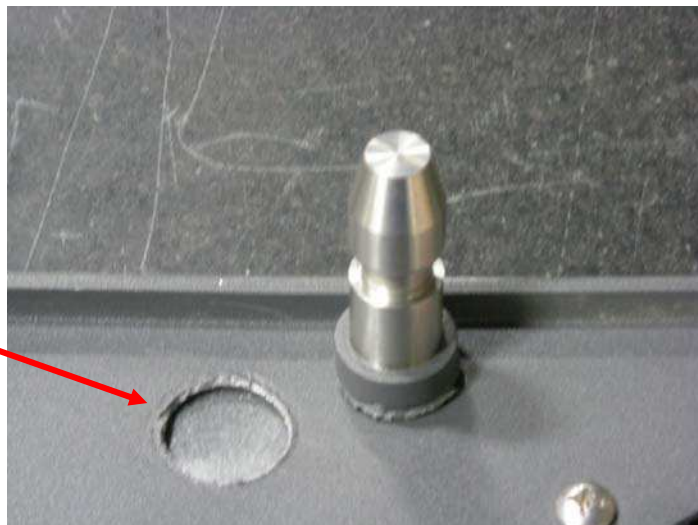
**Cause:** Variation in welding process resulted in undersized weld and poor penetration between shoe bracket and pin.

Fig 1- Weld joint failure on vac shoe bracket weldment 56317063

Shoe bracket weldment with undersized weld and inadequate weld penetration between pin and shoe bracket

On machines with S/N's prior to those noted below remove shoe bracket weldment 56317063 from shoe ass'y 56317041 & replace as shown in Fig's 3-6.

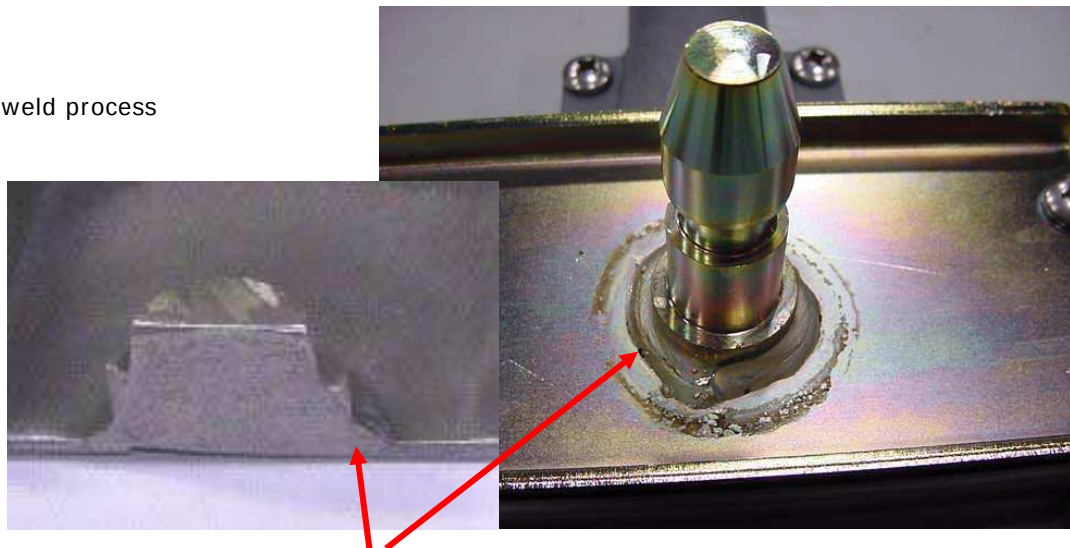
Fig 2- Correct weld process

Weld w/correct fillet size and penetration.

Improved weld process implemented effective with SN 2050515 on AquaPLUS and S/N 2050506 on Adphibian.
