**Number:** TSBFC-2015-031 Various Machines

**Symptom:** Vacuum created in solution tank,  
reduced solution flow

**Date:** December 7th, 2015

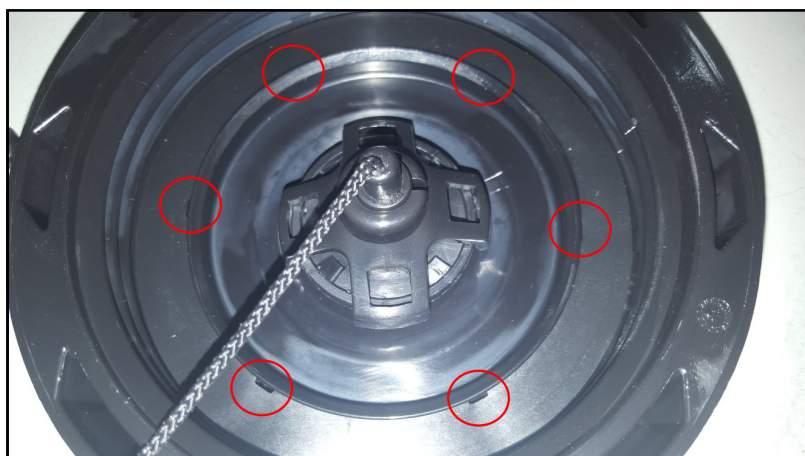
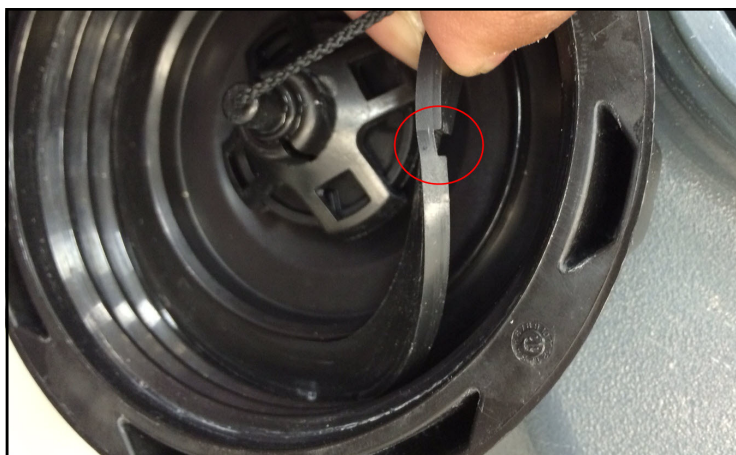
**COMPONENT LOCATIONS / PICTURES:**

The threaded solution tank cap (P/N 56601599) is not venting fast enough and is creating a vacuum inside the solution tank. May only occur when draining the solution tank and when using maximum solution on certain models.

The current 2-Slot Vented Cap when tightened, restricts the maximum solution flow rate to about 0.5 gpm by limiting the amount of air venting back into the tank. If cap is fully tightened on the solution fill opening when trying to drain the solution tank and when using maximum solution flow rates on certain models, a vacuum can develop inside the tank drawing the sides of the tank in.

Replace existing 2-Slot CAP-RAW WITH TETHER (56601599) with new 6-Slot CAP-EXTRA VENT (56510442).  
See pictures below.

**56510442** CAP-EXTRA VENT higher flow 6-slot vented cap with tether
