# Technical Service Bulletin

**MODEL(S) T350 Stand-on Scrubbers**

**SUBJECT:** On-board battery charger failure due to potential voltage backfeed when reconnecting the double-pole battery cable connector. Machine fault code "0xF103"/"●●●●●●●●" (Charger CAN communication fault) will be detected.

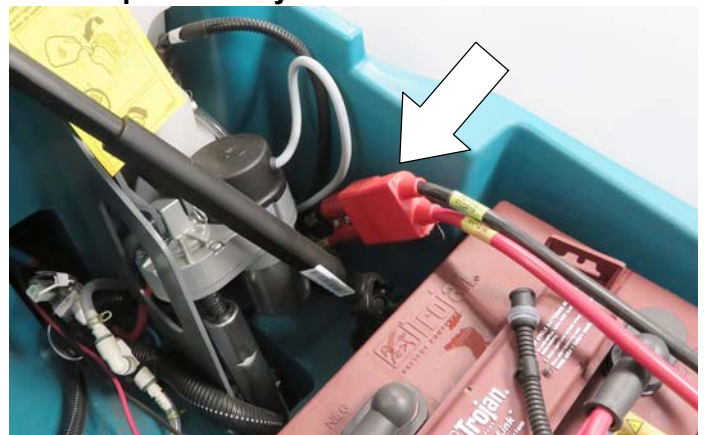
**Affected machines are equipped with double-pole battery cable connectors.**

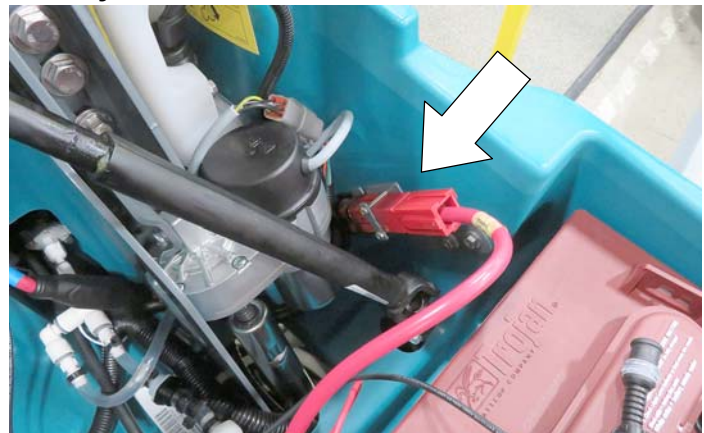
**Picture of reworked machine with single-pole battery cable connectors.**

**PURPOSE:** To repair a failed battery charger caused from voltage backfeed, order Battery Charger Retrofit Kit p/n 9017891. The retrofit kit includes the necessary parts to rework the battery cable configuration with single-pole battery connectors to prevent future battery charger failure.
