Number: TSB-FC-2015-032 Various machines
– Pump wire abrasion

Symptom: No solution output, solution pump not running

Date: September 1, 2015

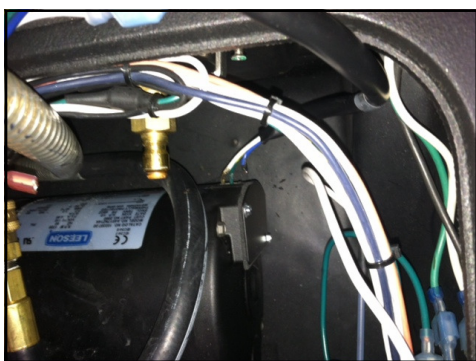
Figure 1

The insulation on the solution pump wires is rubbing against the edge of the hole on the pump motor housing causing abrasion. Overtime vibration from the running pump can cause the insulation to wear out and expose the wires. In the pictures below, the insulation had worn off and the wire contacted the housing causing a short that cased the blue power wire to break. See Fig 1 & 2.

Remove the cover on the end of the motor.(Fig.3) Inspect pump motor wires for damage to the wire or insulation. (Fig.2) Repair or replace wire(s) or insulation if needed. Install protective Grommet (P/N 56050955) inside the pump motor's conduit hole to protect the pump motor wires from rubbing on the housing. (Fig.4,5)
