## TECHNICAL SERVICE BULLETIN

**Number:** TSB-VAC-2023-001 rev2

**Model & Symptom:** VU500—clutch failure

**Date:** Mar 20, 2023

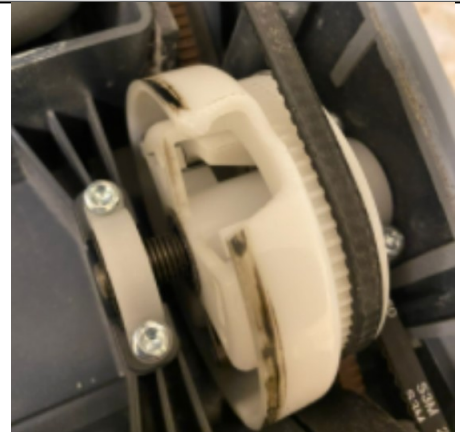
Clutch assembly housing is prematurely failing.

Clutch raw material plastic property do not meet the specification resulting too brittle.

Change to new raw material manufacturer using improved plastic strengthen agent.

Replace the clutch if a failure occurs (fix as fails)

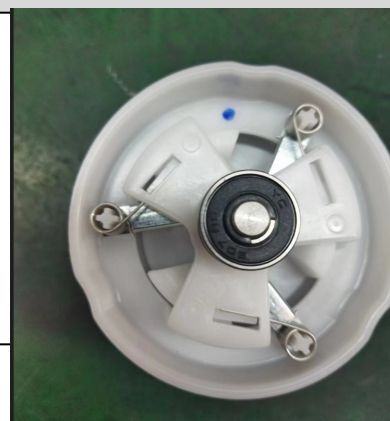
(Fig.1)

**NOTE:** New material assy clutch is marked by blue  
or blue & black dot (see fig.1)
