## TECHNICAL SERVICE BULLETIN

**Number:** TSB-CAS-2019-001

**Symptom:** Need to replace antenna or hood cover

| <b>Products:</b> | All SC50 models. |

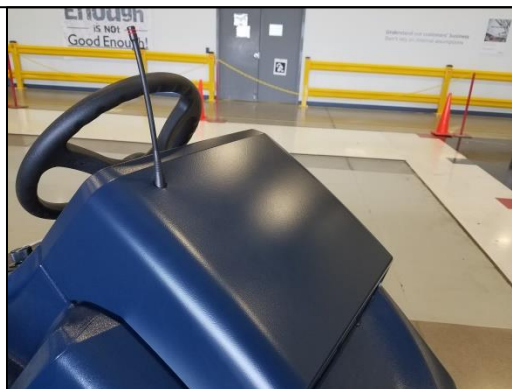
RID antenna is not functional and has been obsoleted. No service parts will be maintained for the 56104624 ANTENNA-REMOTE INTERFACE, 56104858 BRACKET-RID ANTENNA, 56104937 CABLE-ANTENNA-RID, or 56104859 SEAL-RID ANTENNA. The 56104567 HOOD COVER ASSEMBLY has been updated to remove the hole for the RID antenna. If a customer needs to replace the hood, they should remove the RID antenna and components. If a customer needs to replace the antenna or components, they should instead remove the RID antenna, components and replace the hood cover.
