# Nilfisk

## TECHNICAL SERVICE BULLETIN

Number: TSB-CAS-2019-003

Symptom: IoT module not powering up

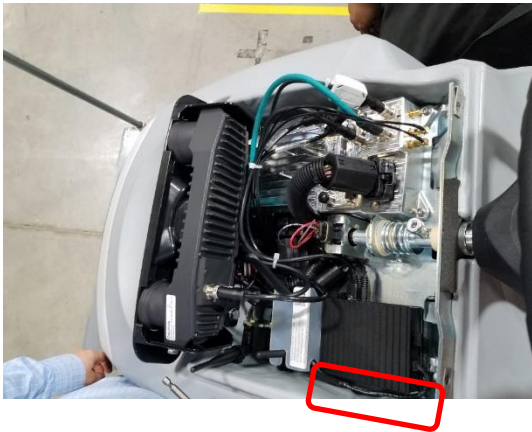
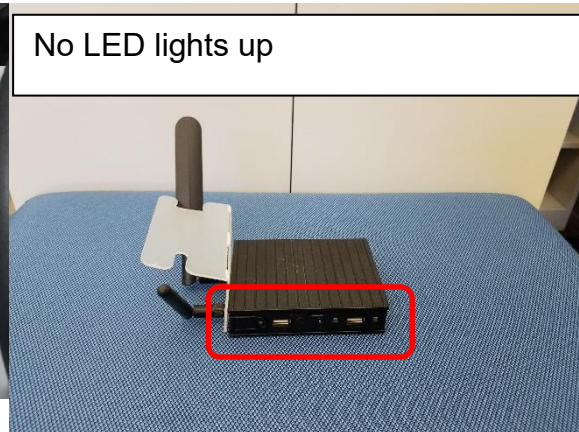
None of the IoT module LED will light up.

No LED lights up

Reach 56122738 harness and verify all pins are seated all the way in the connector by gently pulling it. There is no need to remove any component. If a terminal slides out of the cable, push it in all the way.

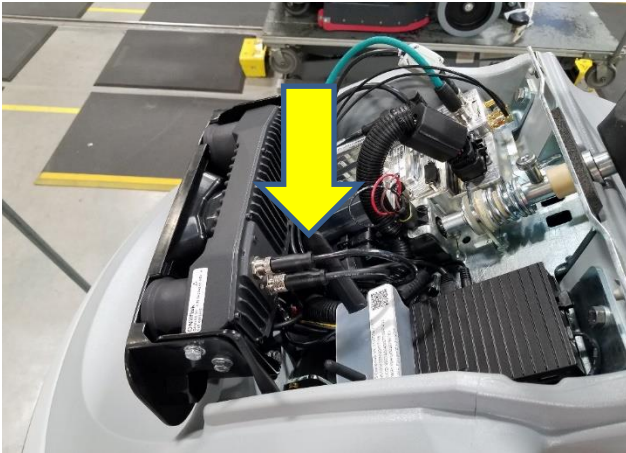
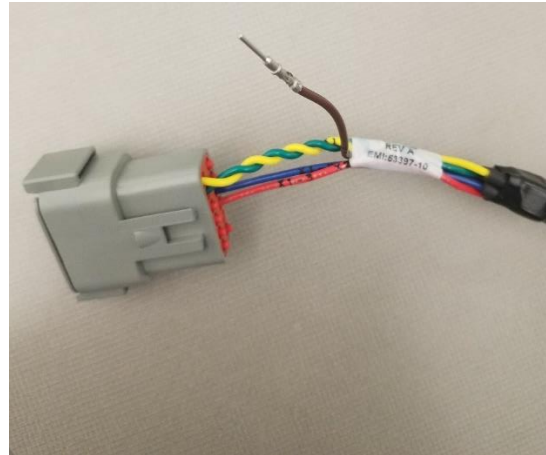
56122738 harness open. Brown wire terminal is not seated all the way in the connector.
