# TECHNICAL SERVICE BULLETIN

**Number:** TSB-FC-2022-010-SC-50

**Symptom:** Squeegee Wheels Locking up due to Debris Ingress.

SC50 & SC1500

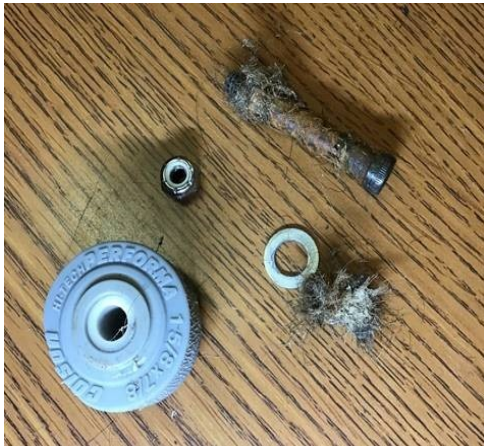
OLD KIT

The squeegee wheels pin and washers are made of steel and are rusting due to the collection of debris able to come through the washers. This causes the wheels to stop spinning and lock up resulting in the squeegee dragging, poor water collection and damage to flooring.
