# TECHNICAL SERVICE BULLETIN

**Number:** TSB-FC-2022-011-SC-50

**Symptom:** Creaking from front of machine Drive Wheel Area

SC50

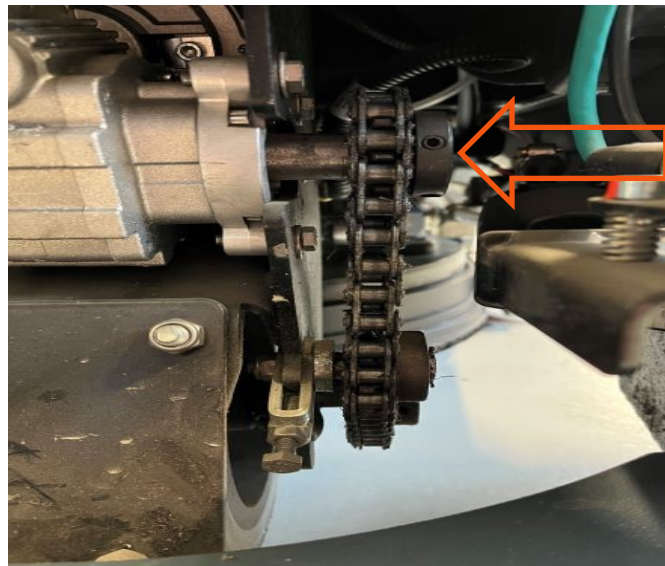
We have had a reported case where the grub screws that hold the chain sprocket on the shaft for the drive chain worked loose causing a creaking noise when driving and the drive chain to be mis-aligned.

A new procedure in production has been introduced to torque, record and calibrate the tools that set the values of the grub screw 56003363 to the correct specification which is 96 in-lb or 10.8 Nm.

Please be aware of this and if you have a SC50 exhibiting these symptoms please check this first as it could be the issue or on your regular preventative maintenance visits.
