## Technical Service Bulletin

| <b>MODEL(S) AFFECTED:</b> | <b>T1 Battery Scrubber equipped with AGM Battery (Model No.: 9008635, 9008636)</b><br>Only models manufactured before serial number 10550969 (December 2011) |
| <b>SUBJECT:</b> | Battery damage due to over-discharge. If machine is not used and left off charger for extended periods, beyond one month, the internal battery discharge indicator (BDI) will continue to draw power from battery resulting in possible battery damage. If battery voltage drops into the over-discharged range, the battery charger will not operate therefore prevent battery to take a charge. |

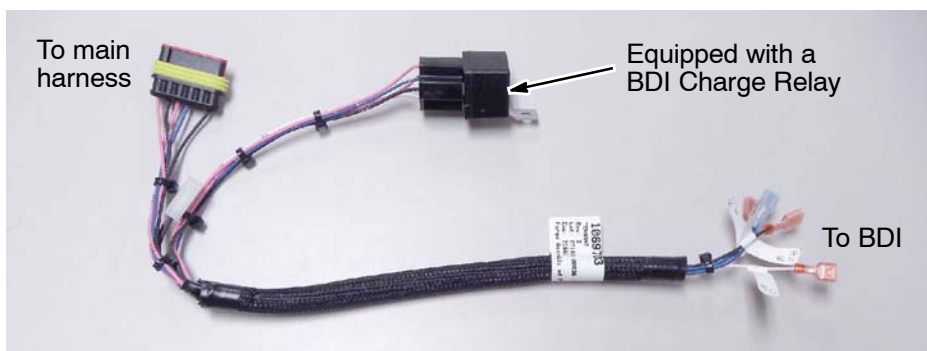
### Upgraded BDI Jumper Harness (p/n 1069703)

Installed on models manufactured after serial number 10550969.

| <b>PURPOSE:</b> | To protect battery from over-discharging, order the upgraded BDI jumper harness (p/n 1069703). The upgraded jumper harness is equipped with BDI charge relay as shown below. |

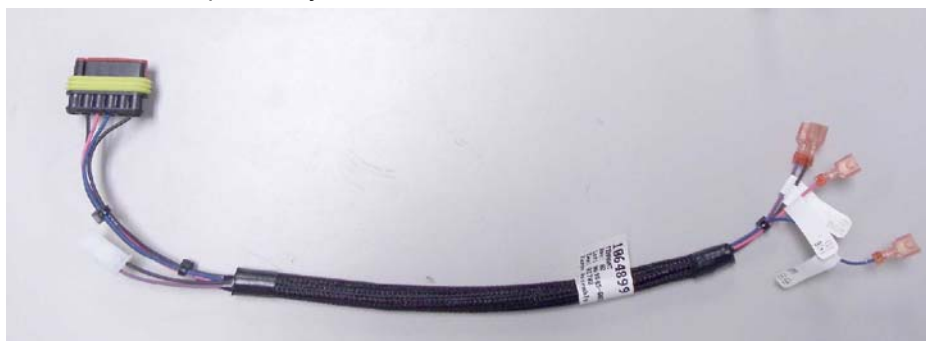
### Discontinued BDI Jumper Harness (p/n 1064899)

Installed on models manufactured before serial number 10550970.  
Now obsolete replaced by 1069703.

**NOTE:** If storing a machine that is not equipped with the BDI relay for extended periods, it's suggested to disconnect the battery cable connections.
