## Technical Service Bulletin

**MODEL(S) AFFECTED:** **Tennant T1, T1B, E5 and R3**

**SUBJECT:** Recovery tank ball-float filter prematurely activates and/or machine has poor vacuum suction. This may be caused by the motor shroud not being positioned properly.

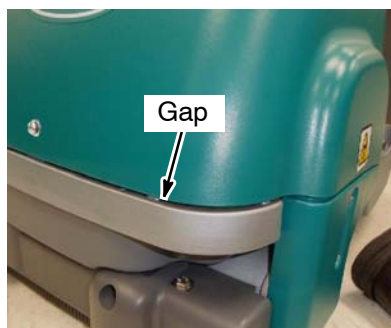
**PURPOSE:** If motor shroud is slightly raised as shown below, the tank gaskets will not form the proper seal with the solution tanks when cover is lowered.

Shroud not properly seated.  
Gap can be as little as 1/16"  
(1.5 mm).

When replacing motor shroud, make sure the shroud is completely resting on the frame. The vacuum exhaust muffler may prevent cover from being completely lowered. Before tightening screws, apply downward pressure on shroud to ensure proper installation.

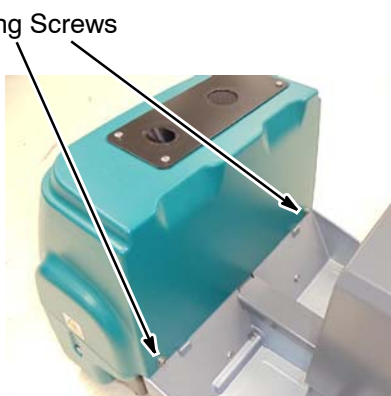
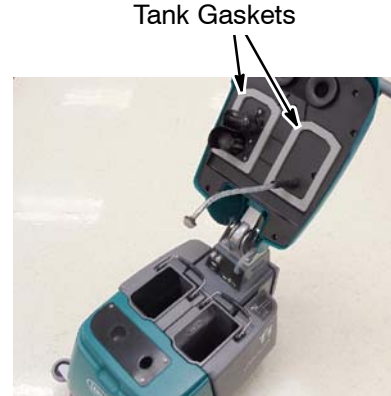
Tank Gaskets

1. Tanks may not be seated in machine properly.
2. Machine cover may be warped or not centered over tanks.
3. Tank gaskets may be worn or damaged.
