## Technical Service Bulletin

**MODEL(S) AFFECTED:** T16 (Only machines where customer has noted CAN bus failures/error messages)

**SUBJECT:** Incorrect CAN bus termination resistance possibly causing CAN bus failures/error messages.

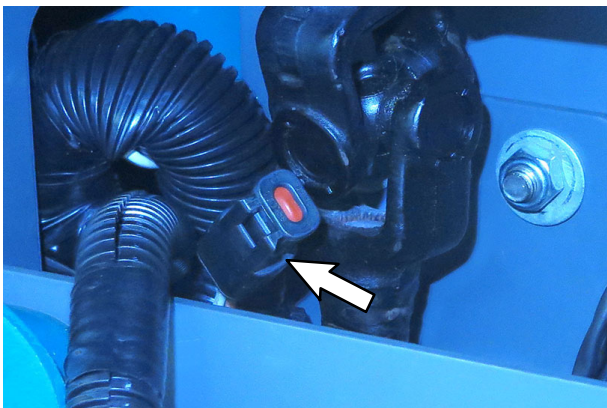
3. Remove electrical panel from machine to access portion of main wire harness/terminal resistor located inside steering support channel.

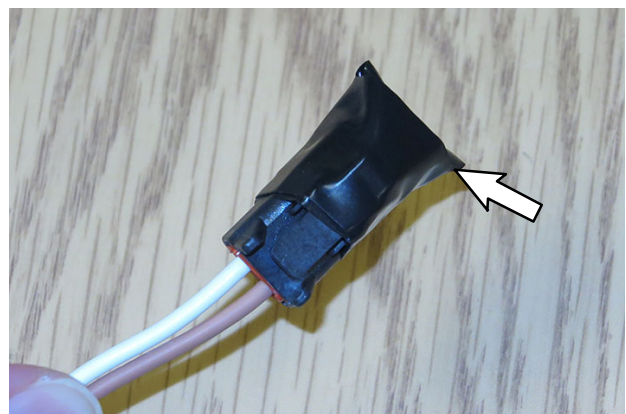
5. Use ohmmeter to test resistance at main wire harness connection where removed resistor was previously located. Should be nominal value of 60Ω.

If less than 60Ω, do not reinstall resistor, tape connector end with electrical tape so connection is completely covered. Discard removed resistor.
