# Technical Service Bulletin

**TSB-IT 2012-092**  
**Floor Cleaning Equipment**

**Subject: drive controller replacement**

07-08-2012

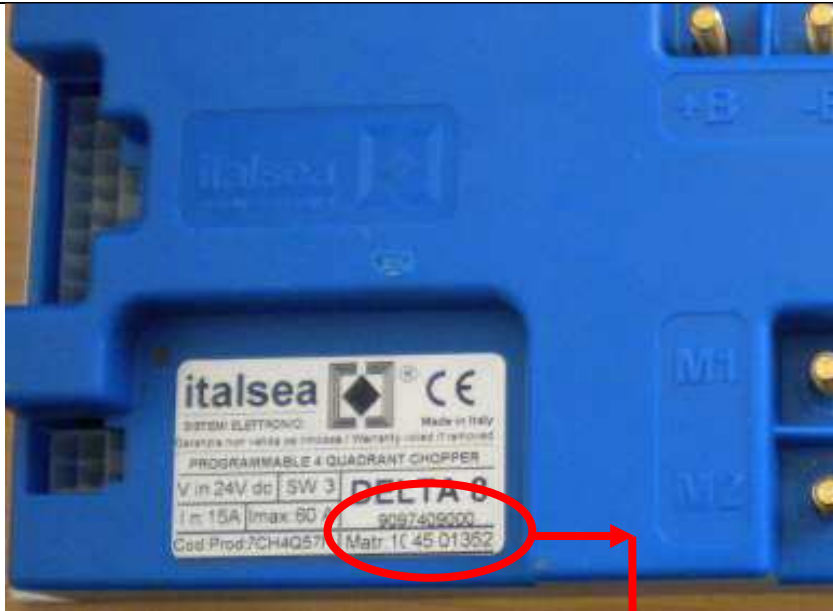
5)  
Identify the label on the drive controller checking the circle the Serial Nr (S/N=Matr 1045 01352)

Drive controller S/N is within the affected range → the drive controller must be replaced.  
Proceed according to the replacement (ref. instructions in following pages)

Drive controller S/N is outside the affected range → the drive controller is OK.
