**Subject:** Loose On-Board Charger Connection  
**Product(s):** All Small / Micro Scrubbers  
20 inch / 51cm or less  
**System:** Charging  
**Number:** TSB-FC-2013-126  
**Date:** 25 June 2013  
**ODM/ECO:** ODM 5260  
**Urgency:** Level 1

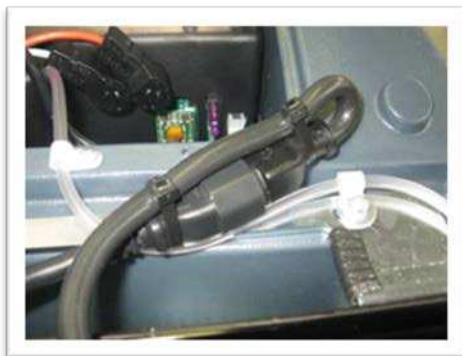
Figure 1

The charger cord repeatedly becomes unplugged

During normal operation the charger cord and the power cord connection point can loosen and become unplugged

- All machines with hidden cable connection points will have cable tie system installed during production (see Figure 1)

- The same effect can be achieved in the field folding the cord over itself and fastening with 2 zip ties, 1 on each side of the interconnect point
