## TECHNICAL SERVICE BULLETIN

**Subject:** New drain hose  
**Product(s):** Mid WB scrubber  
**System:** Recovery  
**Number:** TSB-FC-2013-111  
**Date:** 22 Apr 2013  
**ODM / ECO:** 5053  
**Urgency:** Level 2

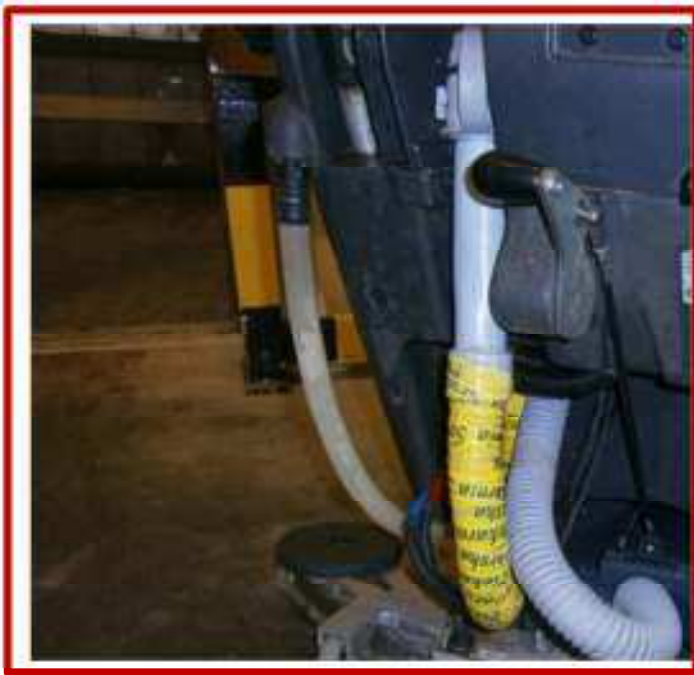
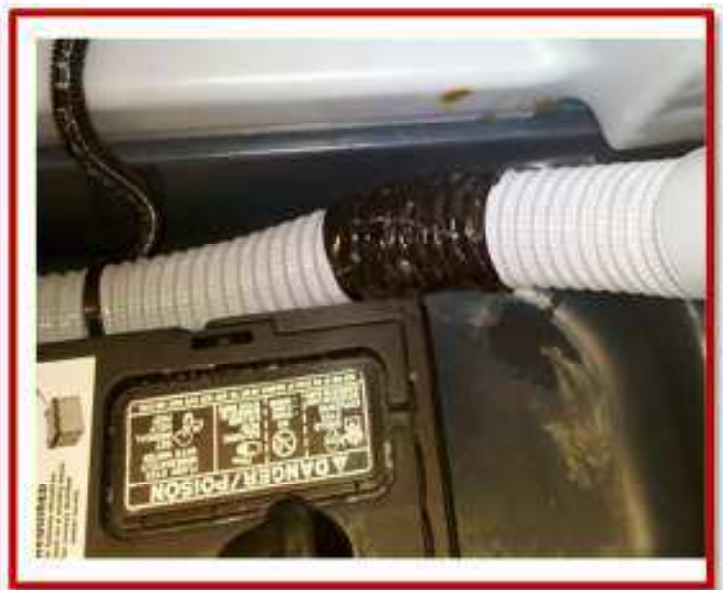
**Issue**

Premature damage of the drain hose.

- 1) Poor resistance to chemicals of the PVC material.
- 2) Hose too stiff prematurely worn out during draining operation/recovery tank cleaning.
