**Subject:** Drive Plate Failure

**Models Affected:** All Boost models

**Issue:** Drive plate part number 30663A fails prematurely

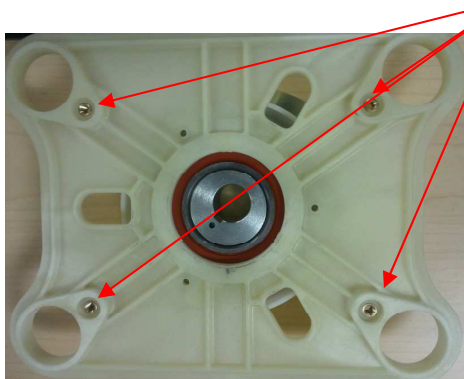
Figure 1

- 1) The Boost drive plate did not have sufficient structure to endure end-isolator failure.
- 2) The attachment screws where the drive plate ends at driver attachment may prematurely disengage due to a dimensional issue with the threaded portion of the drive plate.

- 1) Replace the drive plate part number 30663A with new rib reinforced plate 56381491 (Fig. 1).
- 2) Remove and discard buttonhead screws (56003825) and bushings (56380173) used to retain flex plate.
- 3) Make sure when attaching the drive plate to the pad driver that the portion of the drive plate that goes over the top of the isolator is pressed completely down onto the pad driver.
- 4) Replace screws and bushings with shoulder bolts, part number 56381989 (Qty 4, Fig. 2). Attach to inserts shown below and add Loctite 242 to the retaining shoulder bolts.
