**Bulletin Level:** 2

**Subject:** New upper isolator – **Refer to TSBCL2010-12 for related Boost Deck & Isolator Improvements.**

**Models Affected:** Focus II Boost L20 (all models)

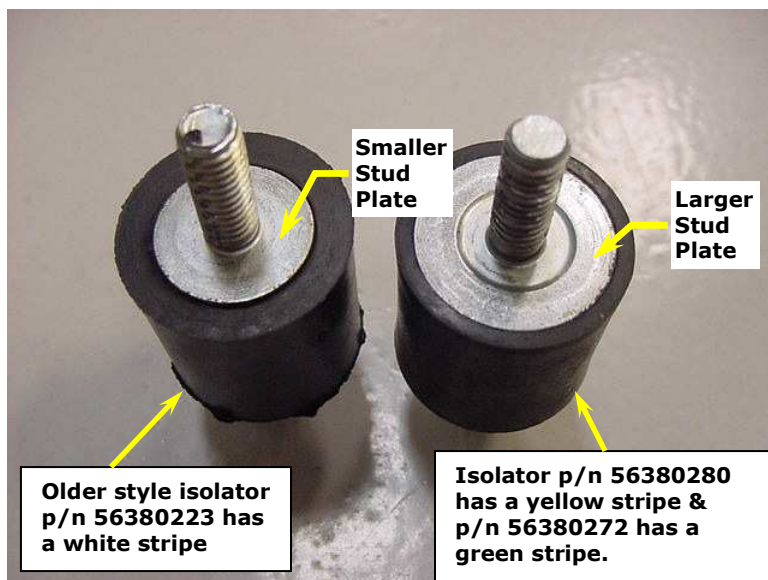
**Issue:** Premature isolator failure during assembly or at low hours

**Cause:** Inadequate bond between rubber body and stud plate

**Corrective Action:** Factory: Effective 6/17/10 with SN 8000025674, Isolator p/n 56380223 was replaced with p/n 56380280 which had a larger stud plate (See Figure 1 below). As a further enhancement on 7/12/10 and with SN 8000027901, isolator p/n 56380272 made from a neoprene vs. rubber material replaced 56380280.

Field: If you experience a premature isolator failure, replace the older style Isolator with p/n 56380280 or 56380272.

**Caution:** When installing the new Isolators, be careful not to overtighten the Isolators or nuts. Install as follows:

1. Apply Loctite to the bottom threads on the Isolator and hand-tighten into the deck.
2. Apply Loctite to the nut on the Isolator top threads and torque the nut to 8-10 in-lbs / 10.8-13.5 Nm.
