## SERVICE BULLETIN

**BULLETIN #:** ???????? **LEVEL: 3** **Page(s): 1** **Date:** 2-20-2008  
**TO:** Clarke Service Centers  
**FROM:** Engineering  
**SUBJECT** 40790B BOOST® brush motor getting water inside  
**MACHINES AND MODELS AFFECTED:** All BOOST models

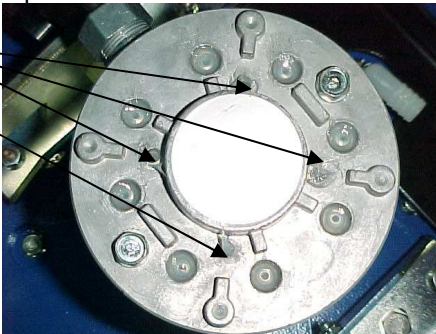
**CAUSE:** The 4 brush installation holes are open and allow water to enter the motor and short the motor out. All other holes are sealed

Four holes to fill  
Only apply enough silicone  
to cover the hole  
**DO NOT** use any more  
than is necessary to cover  
the hole opening

**SOLUTION:** Apply silicone sealant to the 4 brush spring installation holes in the upper end bell of motor 40790B

**ACTION / WORK:** Apply a small amount of silicone sealant to the 4 open holes in the top end bell. You can see how the other 8 holes have been sealed
