## TECHNICAL SERVICE BULLETIN

**Number:** TSB-FC-2019-005

**Symptom:** Exhaust filter cover falls off.

VU500, Carpetmaster

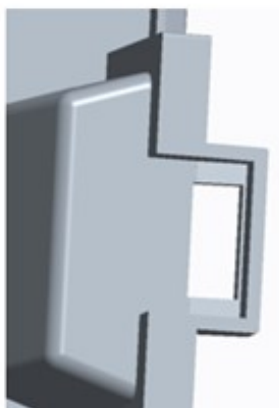
old plastic

Motor cassette latch for the cover breaks.

1. Supplier deviation in the injection parameter so the material is very brittle.
2. Also suspected the VU500 filter cover design change to tighten the HEPA filter cover to reduce air leakage. This made the filter cover harder to close, which increased the stress on the motor cassette filter cover catch when the filter cover was closed in assembly.

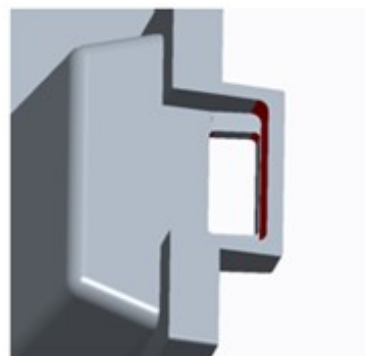
new plastic

1. Phase out the supplier Joinwin.
2. Modified the tool of the motor cassette adding the R0.8mm on the corners and increase the material 0.3mm to make this latch is stronger.

Replace the plastic cassette if a failure occurs (fix as fails)

Open for sale the production P/N 147 0994 000 for field rework purpose.
