DATE: 2/5/24

**SUBJECT:** FM1700, FM2000, & 225BU Strain Relief Retaining Nut

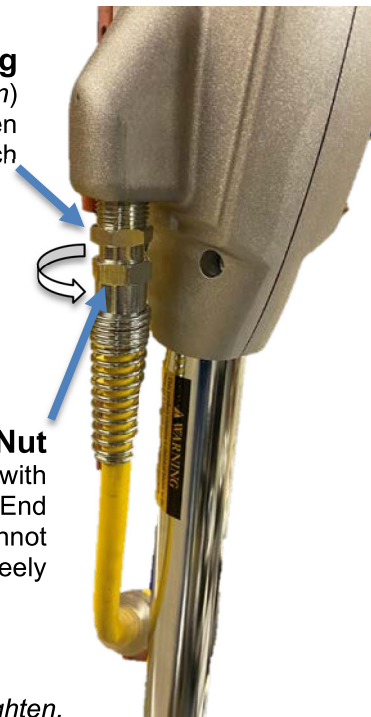
During our inspection process of the 225BU and FM production models it was discovered on some units the pigtail retaining nut had not been tightened properly. When the retaining nut is not tightened properly, the cord or pigtail will move up and down in the strain relief. Overtime this could cause the cord to pull out of the handle, creating a potential for electrical shock.

Please take immediate steps to check all the machines in your inventory to verify the pigtail retaining nut is properly tightened. The retaining nut should be tight enough that the cord cannot move up and down inside the strain relief. The illustration below shows the details as to how to tighten the retaining nut.

**Handle Fitting**

Hold (Do Not Turn)  
with a 7/8" Open  
End Wrench

**Retaining Nut**

Turn Counter-Clockwise with  
another 7/8" Open End  
Wrench until the cord cannot  
move up and down freely

**Note:** DO NOT Overtighten.  
This could damage the cord  
insulation
