Number: TSB-FC-2015-038 SC6500 Pinch Point

Symptom: Potential pinch point on recovery tank near latch bracket

SC6500 All Models

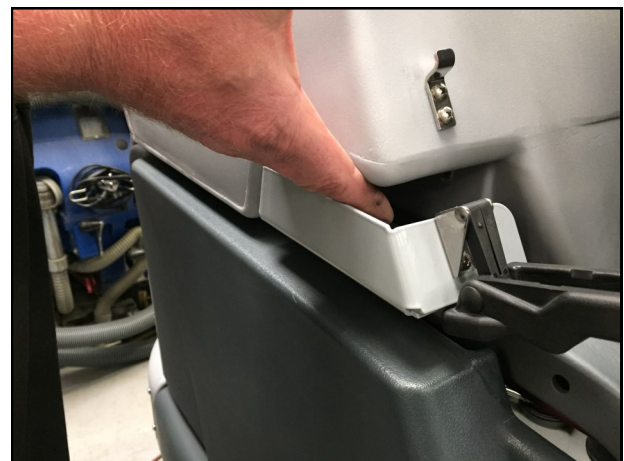
Fig.1 Old design BRACKET-LATCH

When opening or closing the recovery tank, the operator could potentially pinch their hand or fingers. [See Fig. 1]

Variation in the rotomolded tank can create a possible pinch between the latch bracket and the recovery tank.

Replace the old design BRACKET-LATCH with the newly redesigned one if there is not enough clearance.

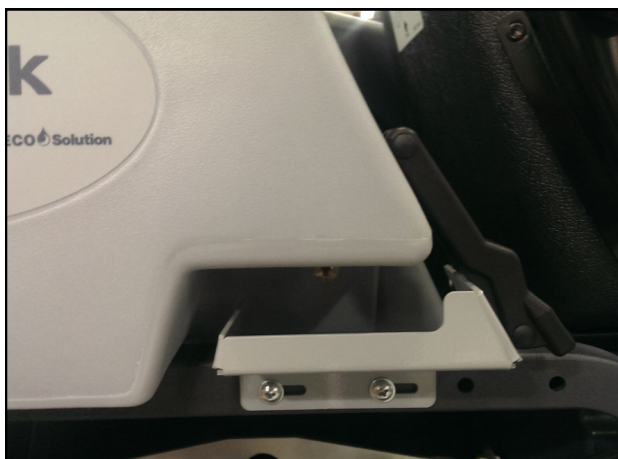
Fig. 2 New design BRACKET-LATCH

The bracket has been redesigned to prevent this from possibly occurring. [See Fig. 2]

56414118 BRACKET-LATCH to increase space between tank and bracket to prevent potential pinch point
