**Number:** TSB-FC -2015-033 Various machines, rear wheel hub cracking

**Date:** Sept. 8th, 2015

Wheel System– Non-traction

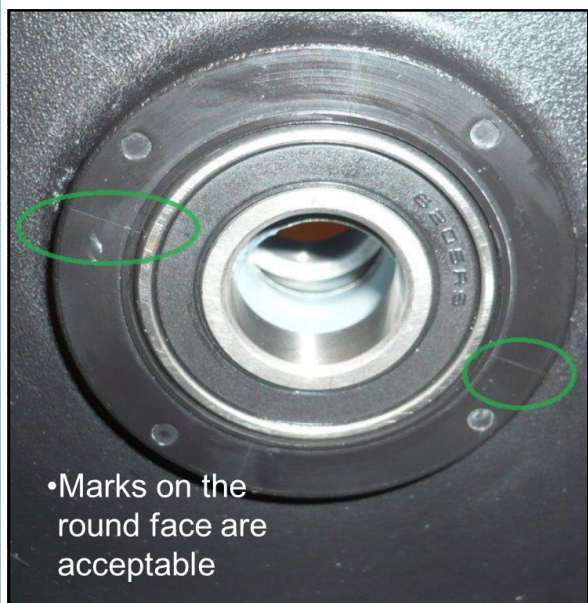
Fig.1

Cracks found on the surface of the round face that do not extend over the hub radius are acceptable (Fig.1) and do not affect the strength of the hub. Hub replacement not necessary.

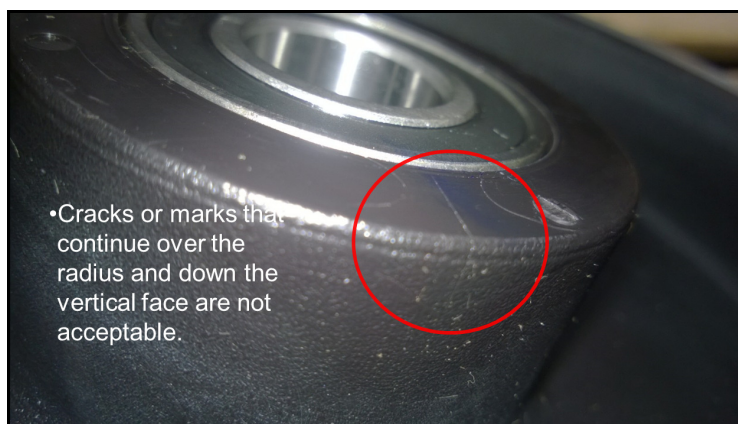
Cracks develop around the inner bearing seat and may cause the hub to fracture around the bearing.

During the injection molding process of the hub, air was not fully expelled from the mold allowing for inconsistencies in the material where cracks could develop.

Cracks that continue over the radius and down the verticle face are not acceptable and should be replaced. (Fig.2 & 3). Any parts with open cracks (Fig.3) should be replaced.

**56382693** WHEEL replace if cracks found similar to Fig.2 or Fig.3 . **.75 hrs. is allowed to preform this repair**
