# Nilfisk TECHNICAL SERVICE BULLETIN

**Number:** TSB-FC-2017-053 Abnormal acceleration/deceleration

**Symptom:** Unresponsive, intermittent or unexpected acceleration/deceleration when activating the foot pedal

**Date:** Aug. 3rd, 2017

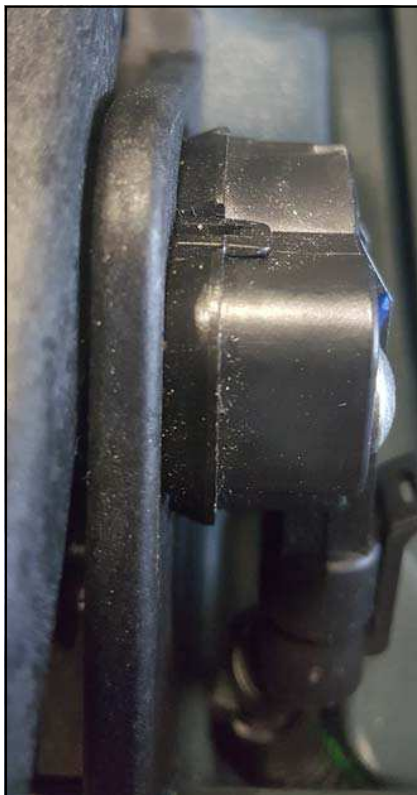
Mechanical misalignment within the potentiometer causing the wiper to inconsistently pass over the resistive element. The potentiometer produces an inconsistent electrical signal to the drive controller resulting in potential unintended acceleration/deceleration or loss of electrical neutral. Defective potentiometers with noisy electrical output may be only identified using precision time-based voltage measuring equipment and is not possible using a typical volt ohm meter.

Potentiometer Without Shim

Replace the existing FOOT PEDAL ASSEMBLY with one the new ones that has a shim. Please see photos below to identify the what has changed. See SPARE PARTS or Kits Needed below to identify the correct replacement part number for the specific model.

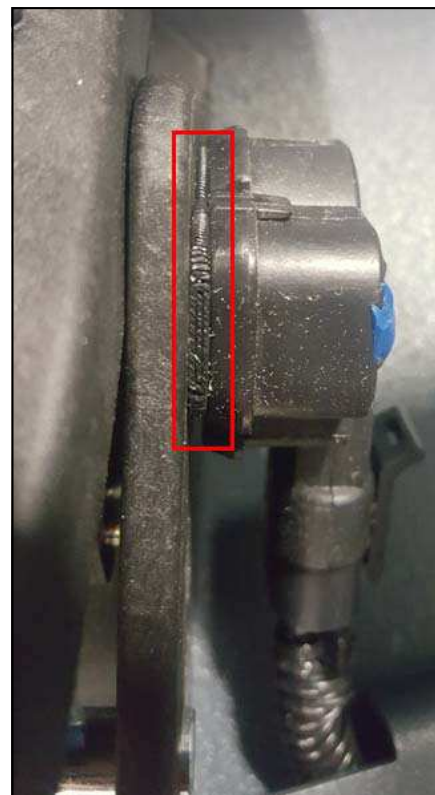
Potentiometer With Shim

A new FOOT PEDAL ASSEMBLY is now being used in production that includes a shim to better align the potentiometer to the pivoting shaft.
