**Number:** TSB-FC-2014-018

**Symptom:** CS7000 Vac motors wearing out prematurely

**Date:** 28th July 2014

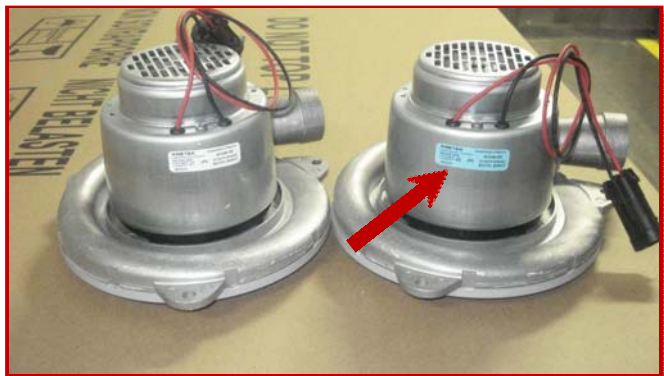
Existing carbon brushes in the vac motors were not lasting to the expected hours of use

Vac motor w/ improved brushes  
has blue label and Ametek Serial  
Number 122257-46

If existing vac motor fails in the field, replace existing motor with PN 56510209

**56510209** MOTOR-VAC-36VDC
