**Number:** TSB-FC-2014-037

**Symptom:** Scrub Deck Actuator Noisy on CS7000

**Date:** November 12, 2014

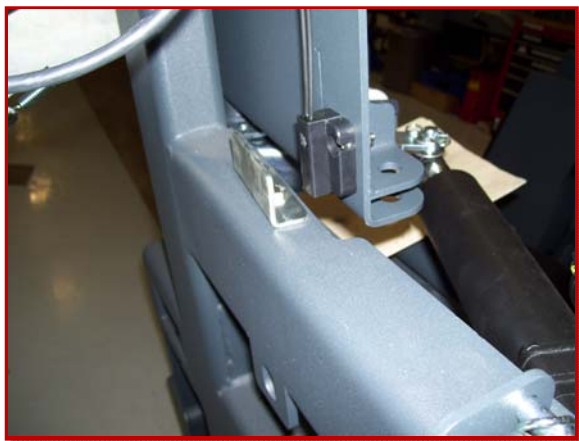
Scrub deck sensor is out of alignment

Deck and spacers may be knocked out of adjustment while transporting machine with deck raised.

**Prox sensor without adjustable bracket**

If the symptoms are observed in the field, order and install PROXIMITY SWITCH BRACKET KIT (PN 56384067)

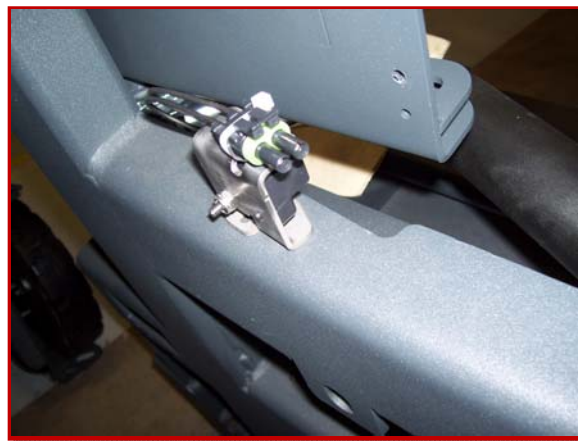
**Prox sensor with adjustable bracket**

**56384067** PROXIMITY SWITCH BRACKET KIT
