**Number:** TSB-FC-2015-003

**Symptom:** Exhaust wraps smoking on CS7000

**Date:** March 31st, 2015

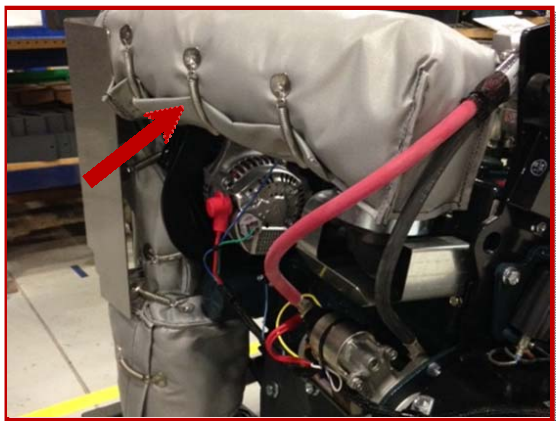
Exhaust wraps are deteriorating under high heat conditions. Seams may open and trap debris that can create smoke or a burning smell

Existing wraps with wire or spring fasteners

Inspect existing wraps in the field. If they are loose, open, or missing any components, replace with the new exhaust wraps. Be sure to inspect exhaust wraps regularly for debris that may be collecting in and around the seams and clean if necessary.

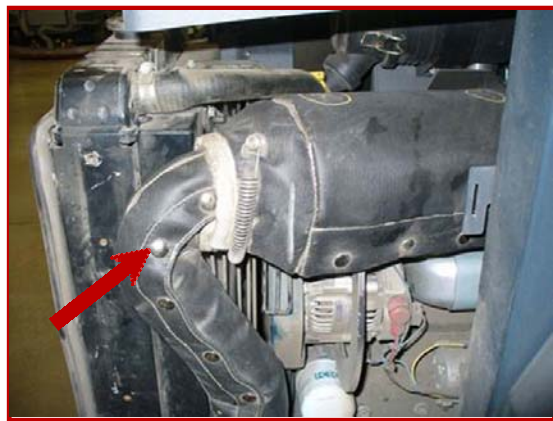
New wrap has snaps

Implementing a new exhaust wrap with a higher heat rating and improved closures

**56384190** EXHAUST BLANKET KIT FOR CS7000
