## TECHNICAL SERVICE BULLETIN NSS<sup>®</sup> Enterprises, Inc.

**Affected Products:** All Charger 2717DB & 2022DB Models

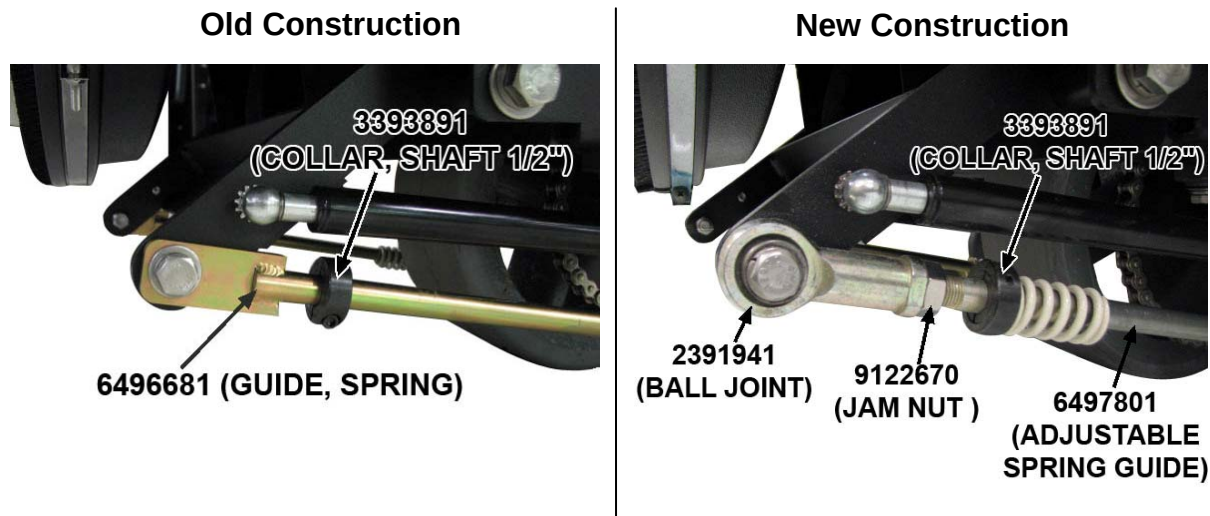
### Illustration:

**Problem Description:** The current system for adjusting pad pressure can be difficult to use.

**Corrective Action:** The 6496681 (GUIDE, SPRING) was replaced with an adjustable spring guide, 6497801, and 2391941 (BALL JOINT). The new construction allows for fine adjustment of the pad pressure by loosening the jam nut and threading the spring guide either in or out of the ball joint to adjust the position of the locking collar.

**Field Installation:** This change is an improvement to the current design, but is not recommended for field installation unless the end-user needs to adjust the pad pressure frequently. Very few end-users should have this need.
