**Number:** TSB-FC-2015-019

**Symptom:** Propane Leaking From Tank Fitting

SC8000 with Propane Engine

Fuel Tank Assembly

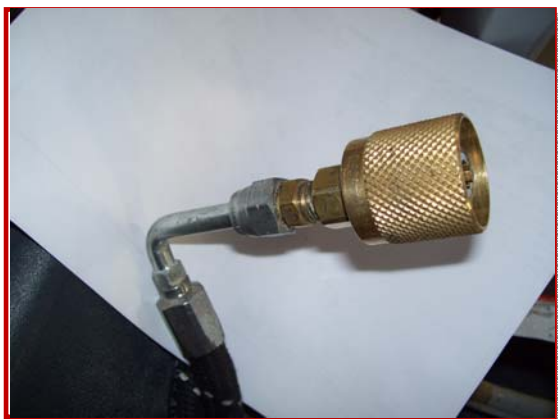
Leakage of propane near the fuel coupling and 90 degree elbow. Potential fire risk.

If the propane tank is installed improperly the 90 degree in the supply line can contact the adjacent fuel hose or machine body compromising the fuel coupling seal or possibly fracture of the 90 degree tube assembly resulting in fuel leakage.

**Old 90 Degree Fitting**

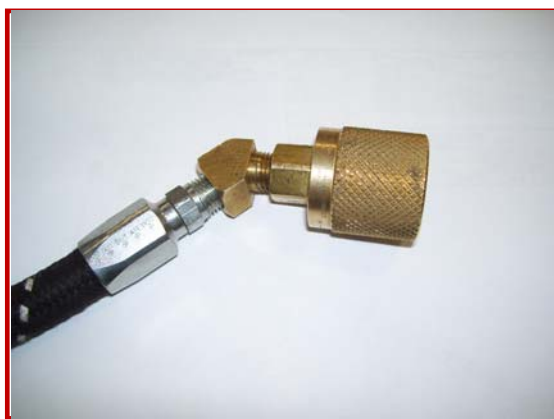
**New 45 Degree Fitting**

A new hose kit with a smaller 45 degree elbow has been implemented to allow more clearance between the hose and LP tank compartment floor. The new configuration also makes it more difficult to reroute the hose incorrectly when connecting to a new tank.

Order and install replacement HOSE-LP KIT PN 56384523 on all machines

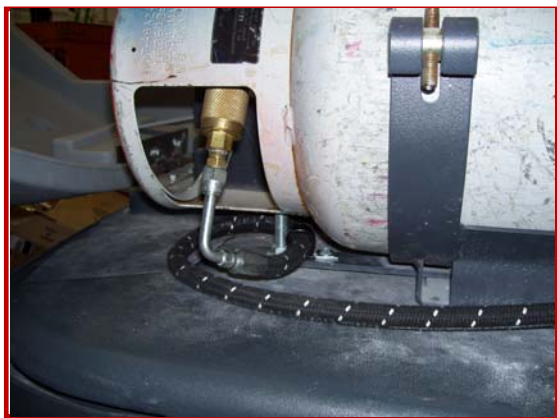
**Old Hose Routing with potential for hose to overlap and press on the fitting causing leak**

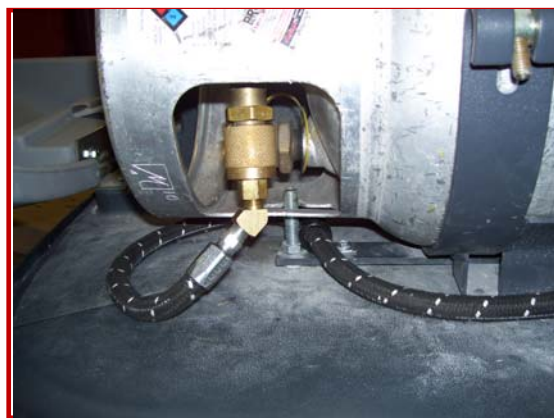
**New Hose Routing with More Clearance**
