Number: TSB-FC-2015-017

Symptom: Vac motor noisy

Date: 6th June 2015

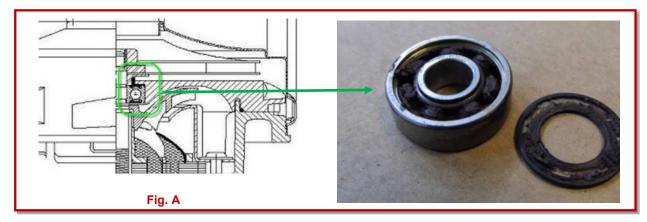
Dirt and wet into the vac motor so the upper bearing rust and get sized (fig.A)

Multiple reasons; due to the position of the vacuum unit and the geometry of the recovery tank, as well the improper use cause water ingress (excessive foam in the recovery tank) or dust ingress (machine vacuuming dry floors)

Fig B1 — seal protection for upper bearing

Fig B2 — filter

- 1. New Ametek motor with added labyrinth and improved seal compound to increase the bearing protection against water. (fig.B1)
- 2. Added filter on the top of the vac inlet to avoid debris enter in the vacmotor fan. (fig. B2)

- 1. Replace the vac motor by the new Kit 9100001238, interchangeability guarantee.
- 2. Add the filter 9100001278 on the top of the vac inlet.
