**Number:** TSB-FC-2015-027 Advolution 2710/  
UHR 70-1700

**Symptom:** Pad Drive Deck not re-lowering to the  
floor

**Date:** July 22nd, 2015

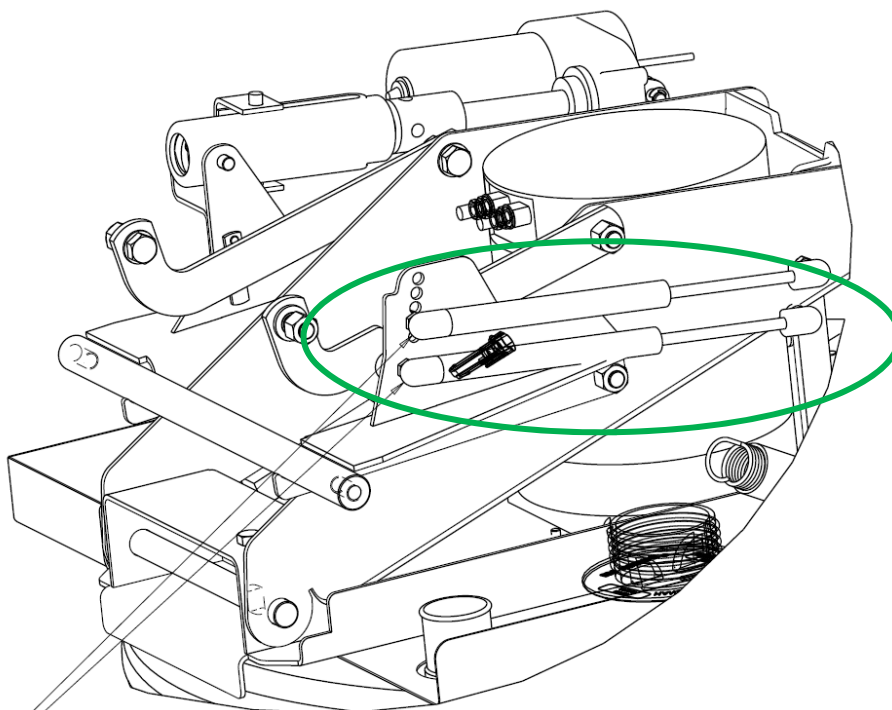
While burnishing on pressure 1 and sometimes 2 the following occurs: The operator comes to a stop, the pad stops rotating and the deck raises as intended to prevent burning the floor. When the operator presses the foot pedal again to begin burnishing, the pad motor starts rotating, but the deck does not fully lower back down to the floor and remains in the air rotating. The operator must fully raise the pad and re-lower to achieve contact with the floor.

When the deck is re-lowered by pressing the drive pedal after coming to a stop, the pad actuator does not lower far enough before the pad begins to spin. The no load free spin amp draw is very close to the target setting so the controller does not further lower the pad to the floor. Adjusting the upper gas shock will reduce the counterbalancing force and allow the actuator to reach the floor again after coming to stop and pressing the pedal to continue burnishing.

The base end of the upper gas cylinder will need to be moved from the third hole from the top to the fourth hole from the top .

←PLACE GAS CYLINDERS IN FOURTH HOLE FROM THE TOP AND IN THE BOTTOM HOLE.
