**Number:** TSB-FC-2015-025 CS7000

**Symptom:** Squeegee will not lower– Error Code 39 on display

**Date:** 20th July, 2015

Electrical System — MAIN PCB BOX ASSEMBLY

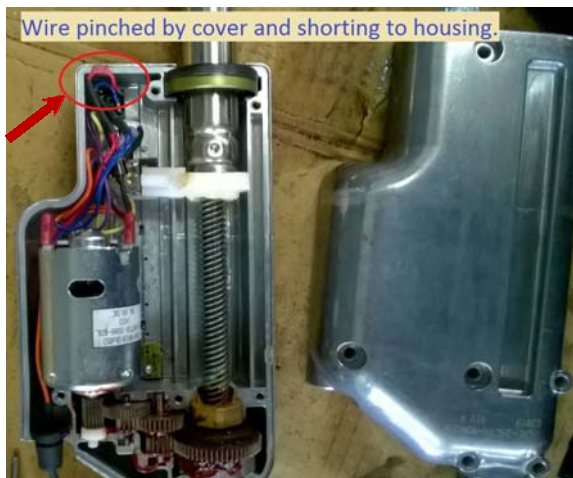
In some applications the main (PCB) control board squeegee actuator output may exhibit reduced life, especially if the actuator circuit is drawing excessive amperage. In some cases the internal actuator wires have been found shorting to the housing causing the circuit to overload.

Replace Main Control Board. Before installing new board, the wiring to the actuator should be checked for a short to the frame. The internal wires in the squeegee actuator should be inspected for a possible internal short to the housing. Remove the actuator cover and inspect the wires. See Fig.1 & 2

**56509247** ACTUATOR SQUEEGEE LIFT - If internal short is found or if actuator is drawing more than 5A while running
