# Technical Service Bulletin

| MODEL(S)<br>AFFECTED: | T7 Rider Scrubber |
| SUBJECT: | Drive motor wires may need to be repositioned to avoid wire abrasion when making right and left hand turns. Inspect the wire harness for clearance and if necessary reposition the wires as described below. |

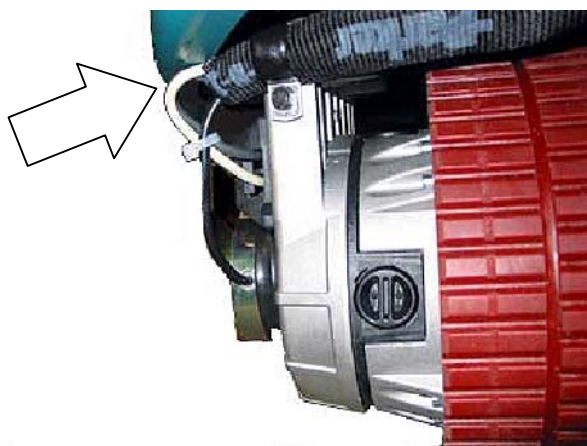
Abrasion point when making a left hand turn. Comes in contact with rotomold edge.

To reposition the wire harness to avoid abrasion:

1. Loosen the two cable clamps and move the wire harness away from the abrasion points. Re-secure clamps.

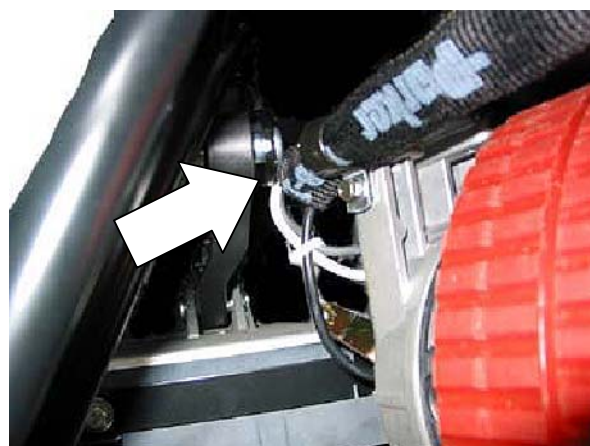
Abrasion point when making a right hand turn. Comes in contact with the scrub head pivot arm.
