**Number:** TSB-FC-2015-034 CS7000 Solution manifold leaking \*UPDATED

**Symptom:** Water leaking from solution manifold

**Date:** 15th Feb. 2016

Model Name: CS7000

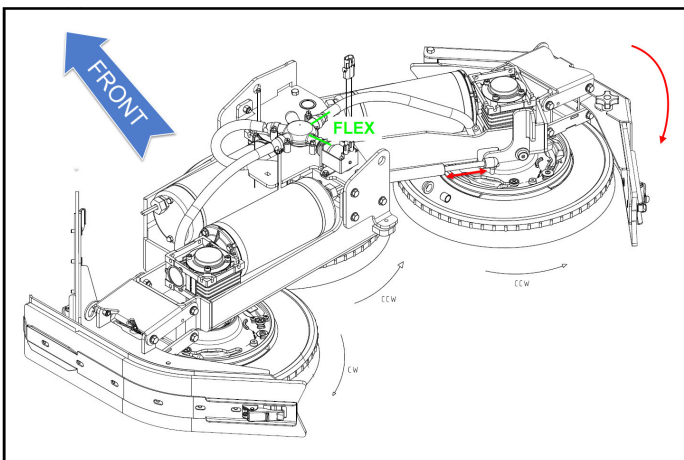
Fig. 1

The right scrub brush motor and bracket will pivot back and inward to allow for more effective edge cleaning while protecting the deck from impact with an object or obstacle. (Fig.1) When the deck pivots back and inward the solution hose for the right scrub motor also moves causing the manifold to flex and split at the seam allowing water to leak out the seam while scrubbing. (Fig.1&4) When not scrubbing, the solution solenoid prevent water from entering the manifold.

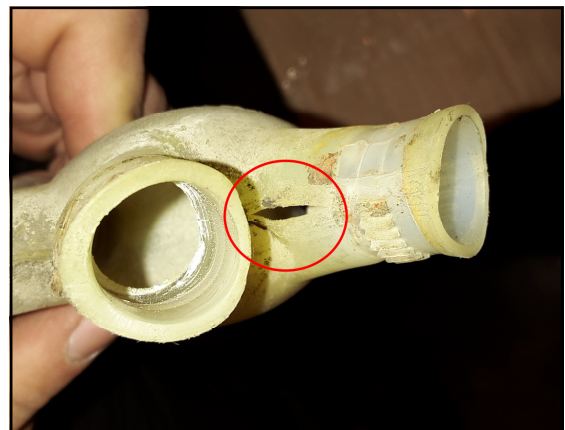
Fig. 2

While scrubbing water leaks from a seam on the solution manifold on to the top of the scrub deck. (Fig.2&3)

**56384703** MANIFOLD BRACKET KIT (Fig. 5) - Replace manifold and install new bracket if leaking from seam (Fig.2) **2.5 hours is the allowed labor time to do this repair.**
